**Wood Research
& Development**

Viability of Modern Timber Highway Bridges

Chris Legg, Architect, Senior CAD and Report Specialist

Dan Tingley, Senior Timber Structures Engineer/Wood Technologist, PhD | PEng (CA) | MIEAust | CPEng | RPEQ (AU)

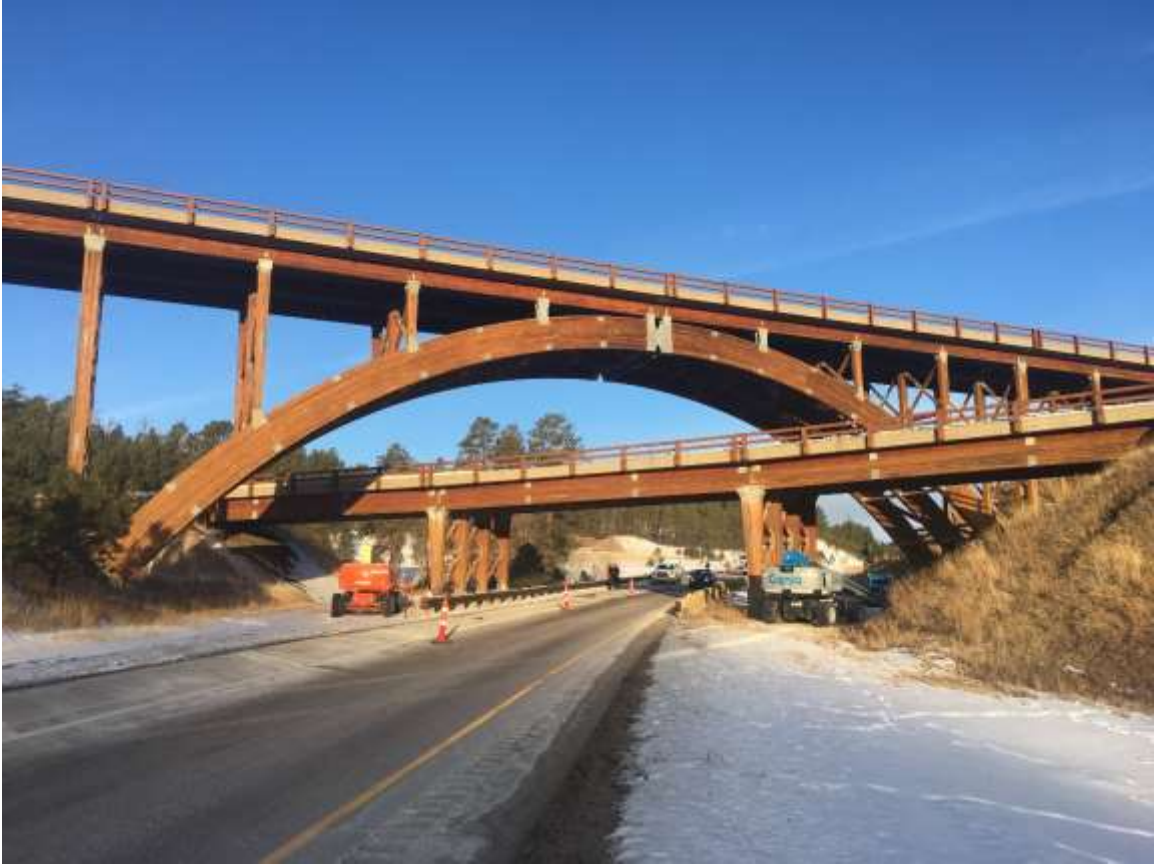
Figure 4-1: The Keystone Wye Bridges in South Dakota were recently inspected after more than 50 years in service, and were found to be in good condition; only minor repairs and routine maintenance were recommended to extend the longevity of the structures.

An in-depth inspection of the structures, including non-destructive testing, was conducted in 2018 by Wood Research and Development, after the bridges had been in service for over 50 years. The inspection was commissioned to confirm the need to spend over 20 million dollars which had been allocated to replace the bridges. The senior bridge officials had been told by their outside consultants that timber bridges didn't last much longer than 50 years and they should be ready to replace these two bridges. The inspection found both structures to be in good condition, and recommended only routine maintenance to extend the life of the structures. The bridge has now been reinstated for another fifty years and will not be replaced. See Figures 4-1 to 4-4 below.

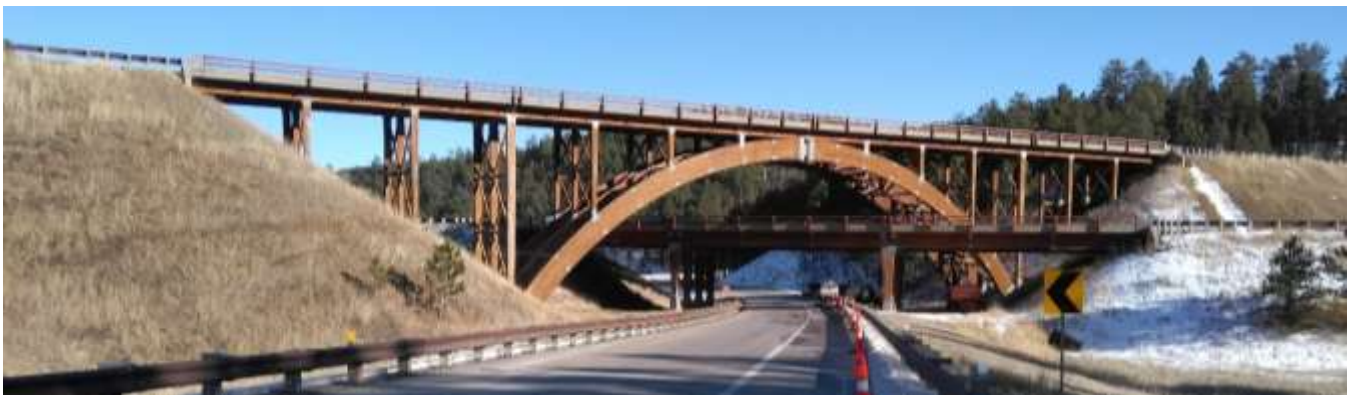
Figure 4-2: The wye includes an upper bridge supported on three-pinned glulam arches, and a lower three-span bridge supported by glulam girders.

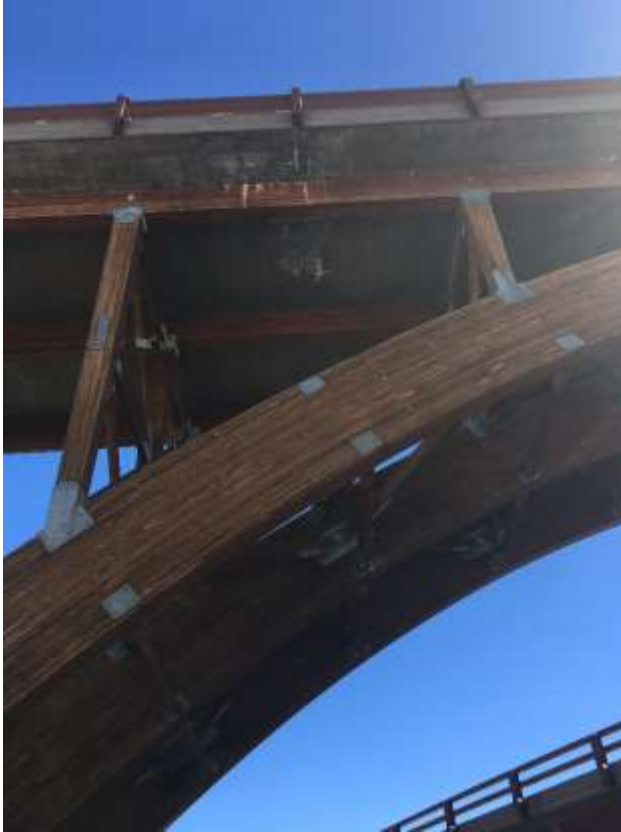
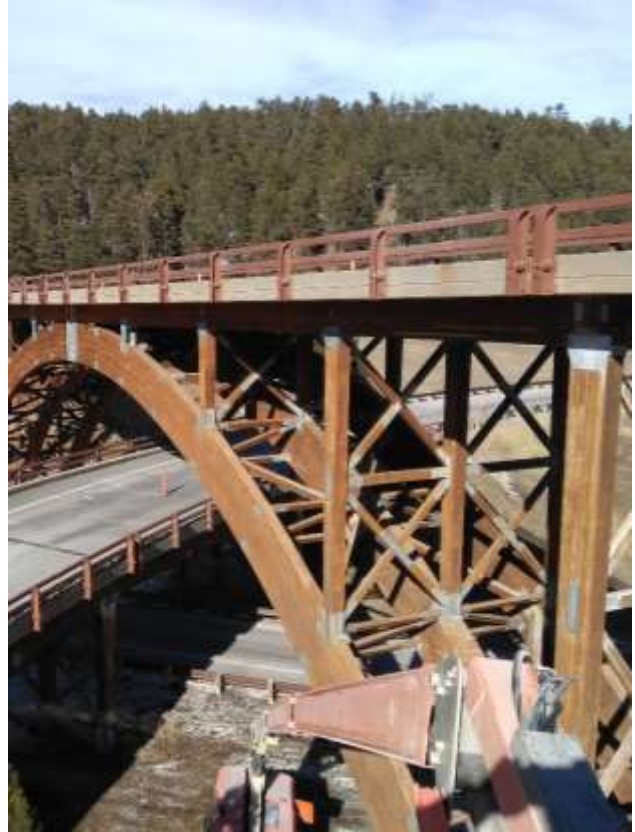
Figure 4-3: The upper bridge is supported by glulam arches.

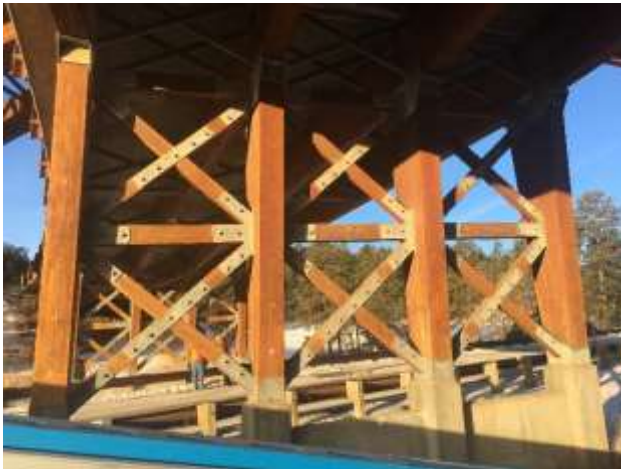
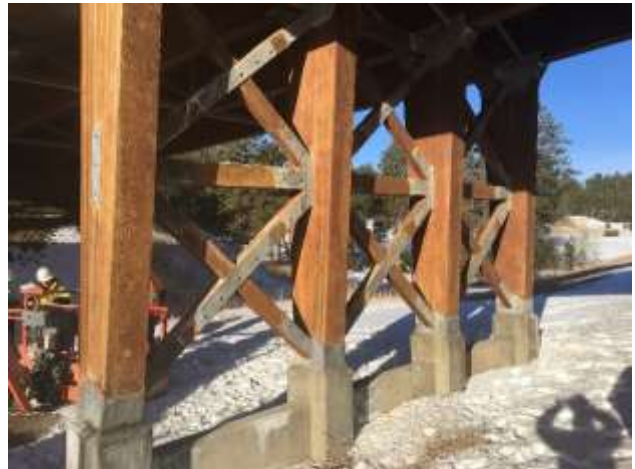
Figure 4-4: The substructure of the lower bridge consists of glulam timber frame bents.

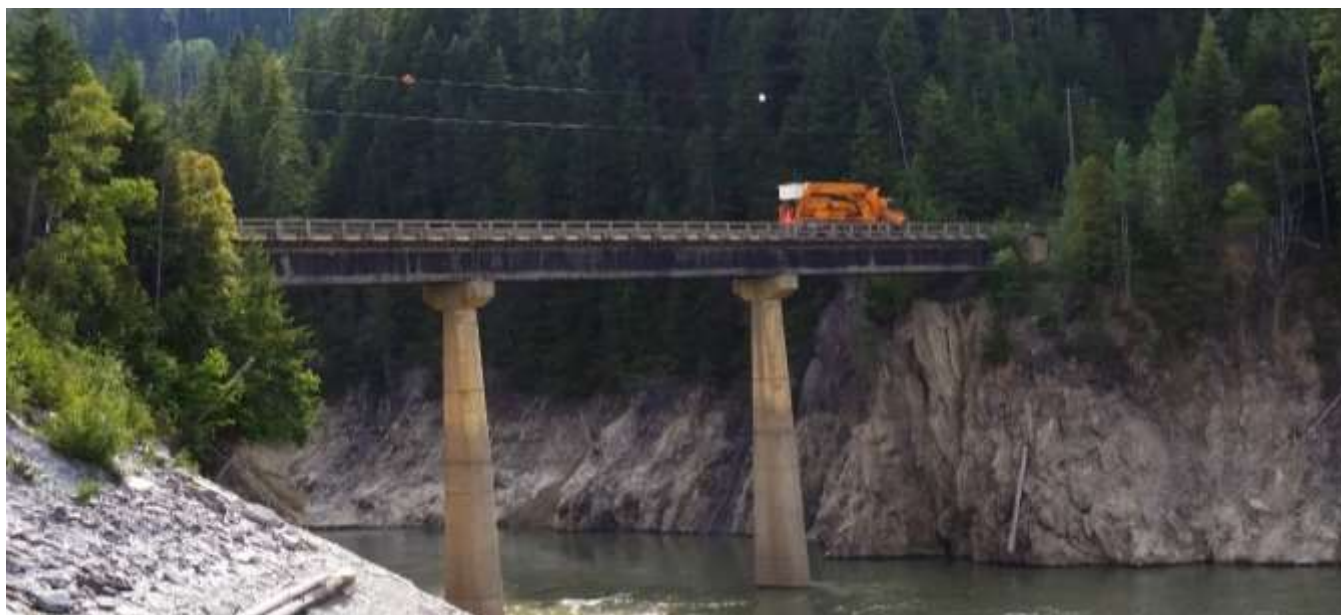
Figure 4-5: Golden Bridge, in British Columbia is a 3-span glulam timber bridge, totaling 82m (270 ft) in length.

Golden Bridge a 3-span forestry bridge in British Columbia. Each span is (90ft) long, and consists of two glulam I-beams supporting a solid-sawn primary transverse bearer and secondary longitudinal deck plank and running boards deck system. Constructed in the 1960s, the bridge was recently inspected and found to be in fair condition; it was found that in its current condition, the bridge can still support an L100

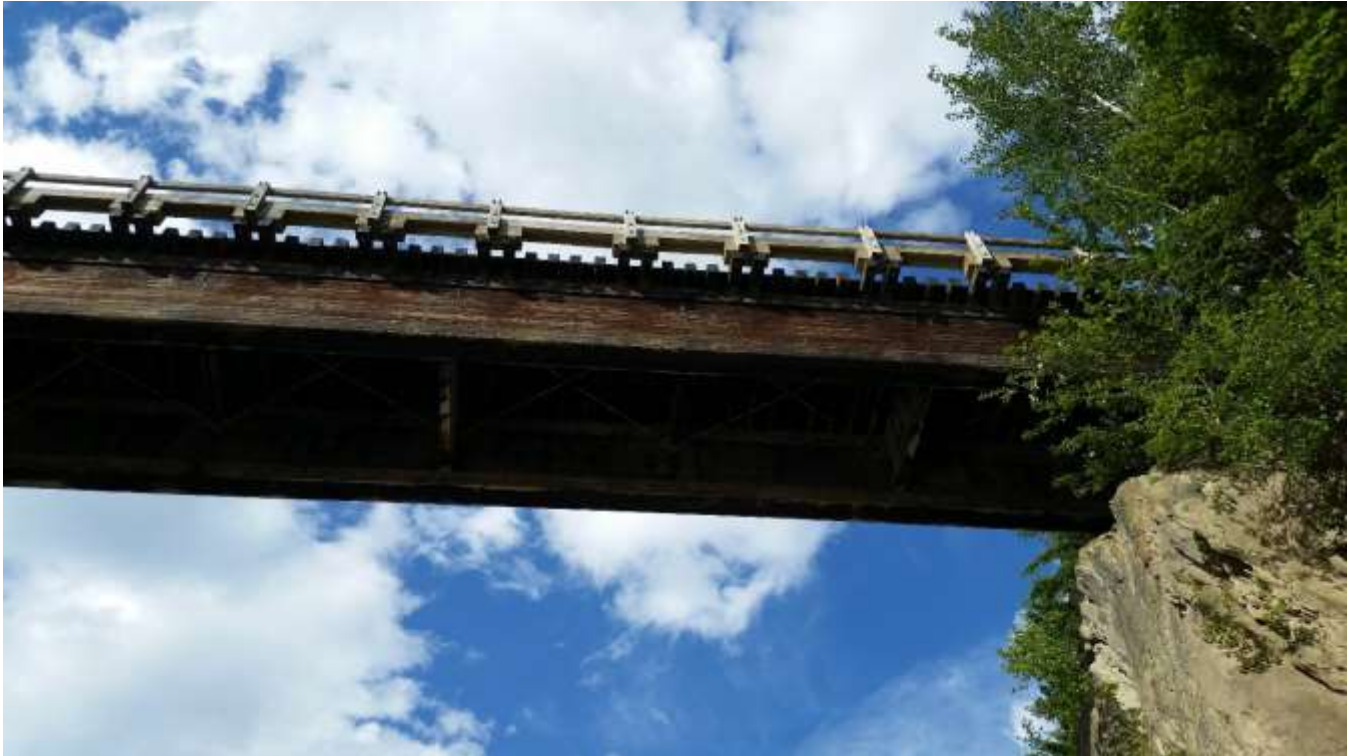
Figure 4-7: A recent inspection of the bridge found it to be in fair condition overall. The only significant deficiencies found were in the deck system as a result of vertical fasteners allowing water to penetrate into the timber elements. Even with these deficiencies, the bridge can maintain an L100 load rating. Recommendations were given for repairs and maintenance that could extend the life of the bridge for as much as 80 more years.

load rating as per S6-14 (Canadian Bridge Code). However, the inspection did reveal some deficiencies in the deck, primarily due to the use of vertical fasteners which have allowed moisture to penetrate into the timber elements. It was recommended that the deck be upgraded to a system that avoids the use of vertical fasteners. This bridge was slated for replacement because the engineers of record had determined that the bridge had reached the end of its life and that assessment was made based on the misconception that timber bridges only last for 40 years. This is a popular misconception based on assessments of timber bridges where poor design and construction detailing has been utilized. See Figure 4-5 to 4-7 below.

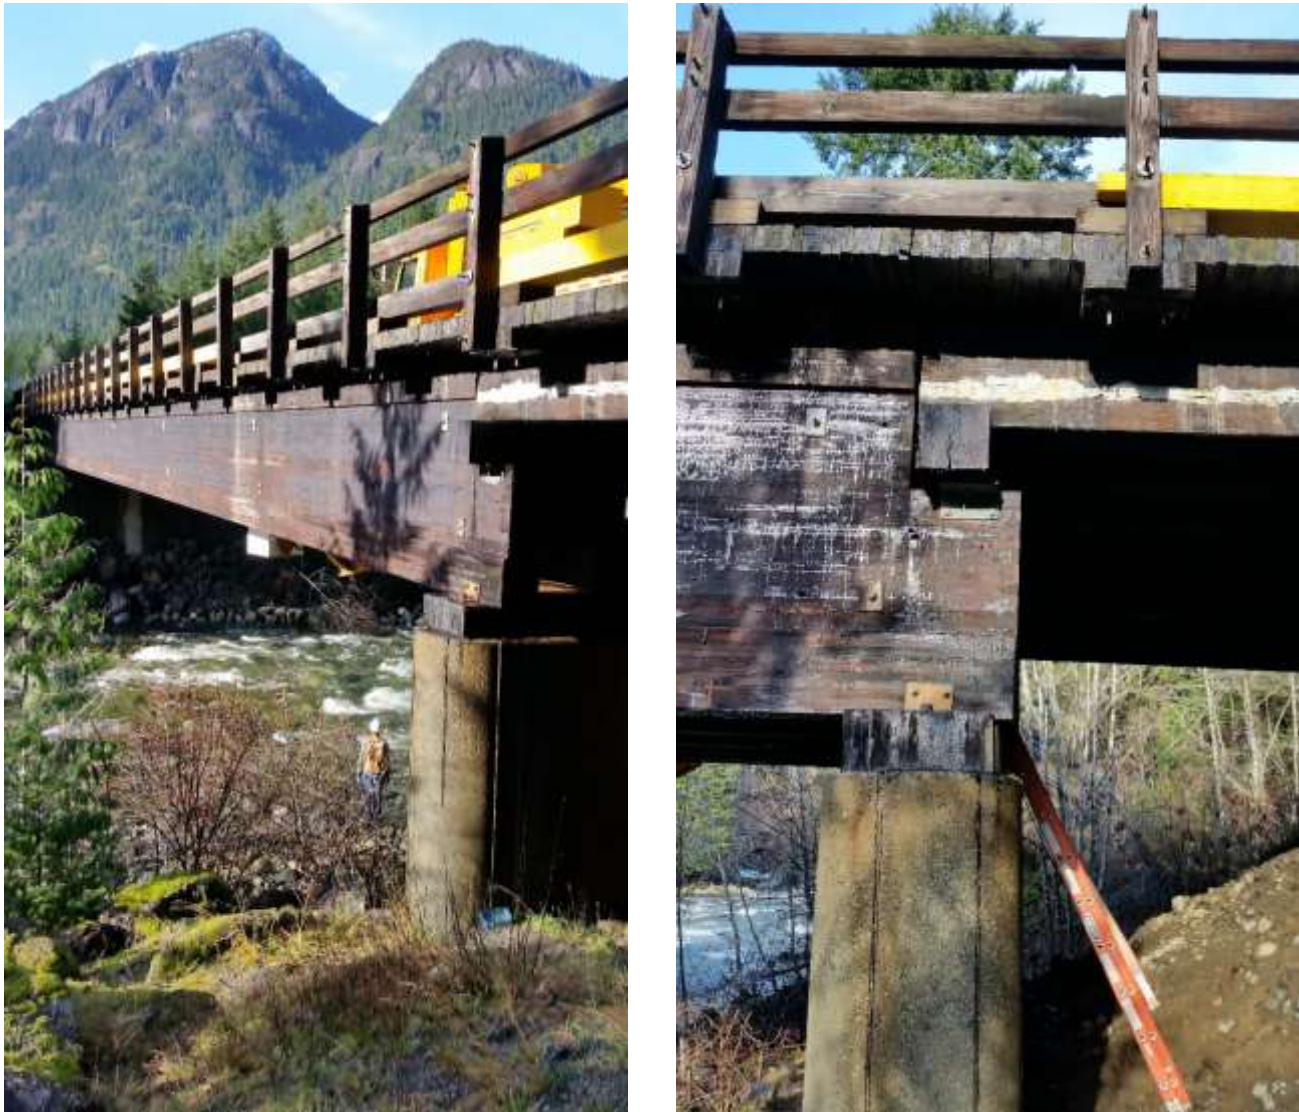
Figure 4-8: Elk River Bridge consists of six glulam I-beams spanning 35m; at each end is an approach span of approximately 8m made up of solid sawn girders. The deck is transverse nail-laminated timber.

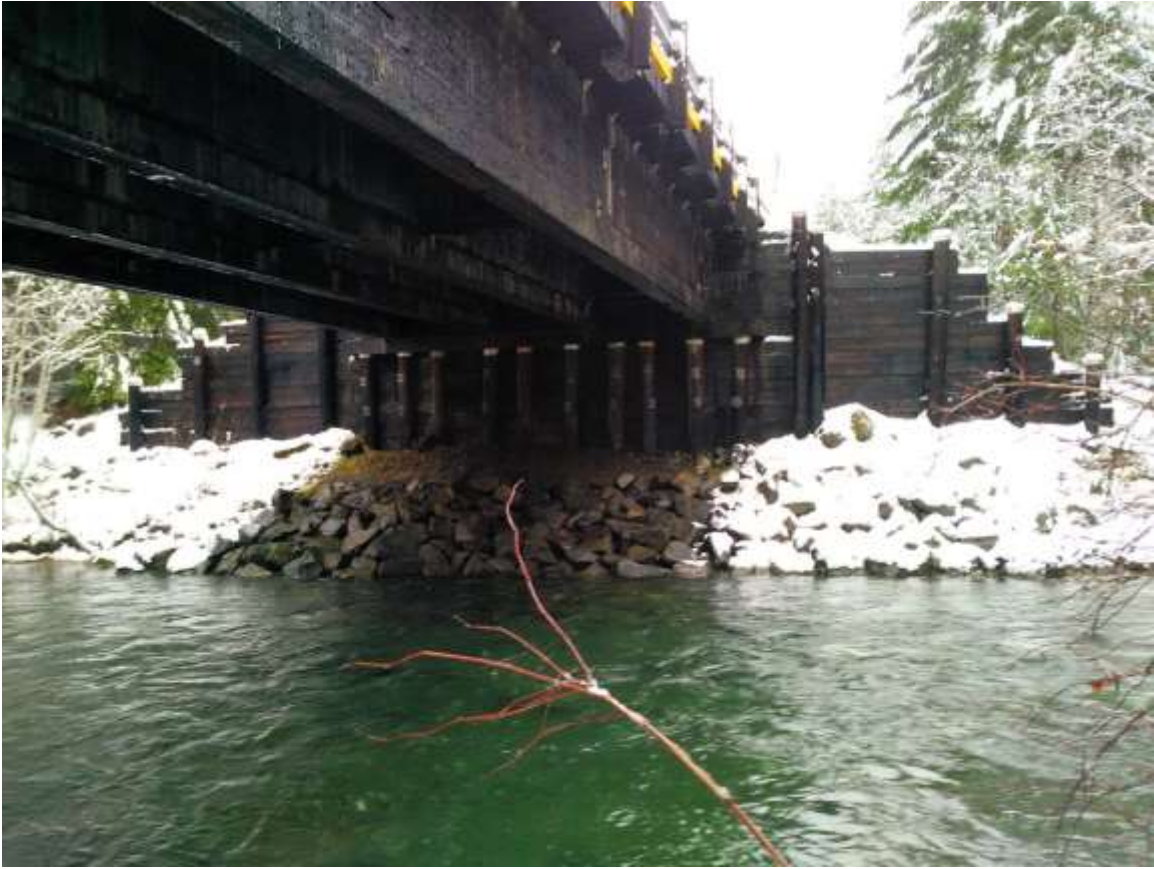
Figure 4-9: Cervus Creek Bridge is a 25m (82ft) single-span bridge consisting of four glulam I-beams with a transverse nail-laminated deck.

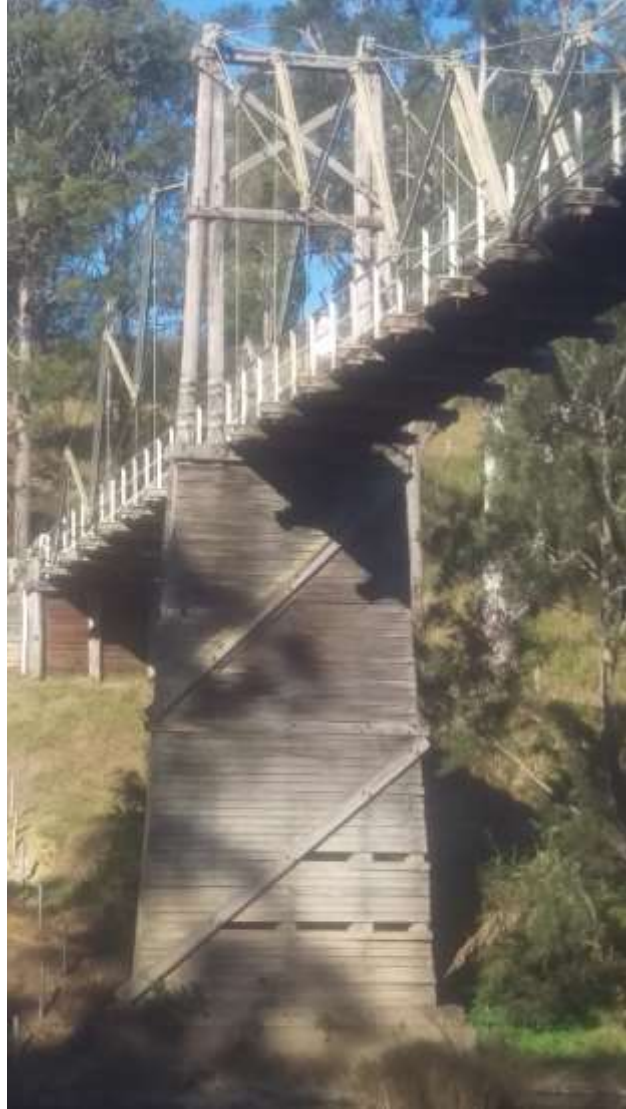
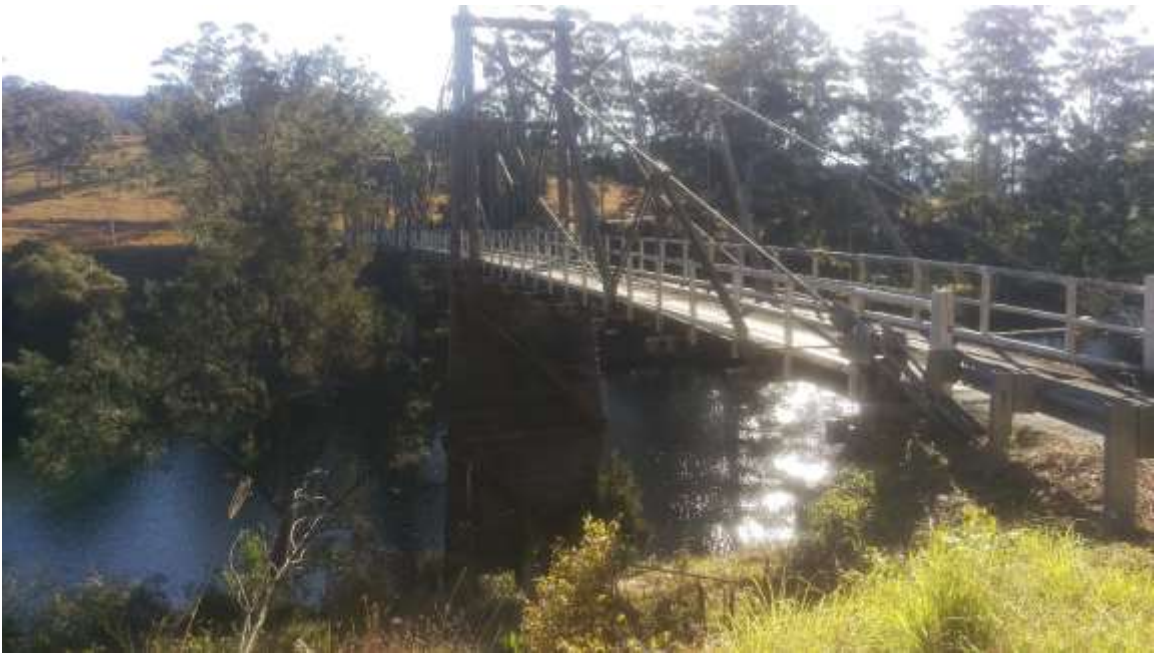
Figure 4-11: Kindee Suspension Bridge.

The Kindee bridge is the oldest longest suspension bridge in New South Wales, Australia with a length of nearly 90 meters. It is rated for vehicle traffic and continues on in service today (2019) as per AS5100 the Australian Bridge Code. See Figure 4-11 below.

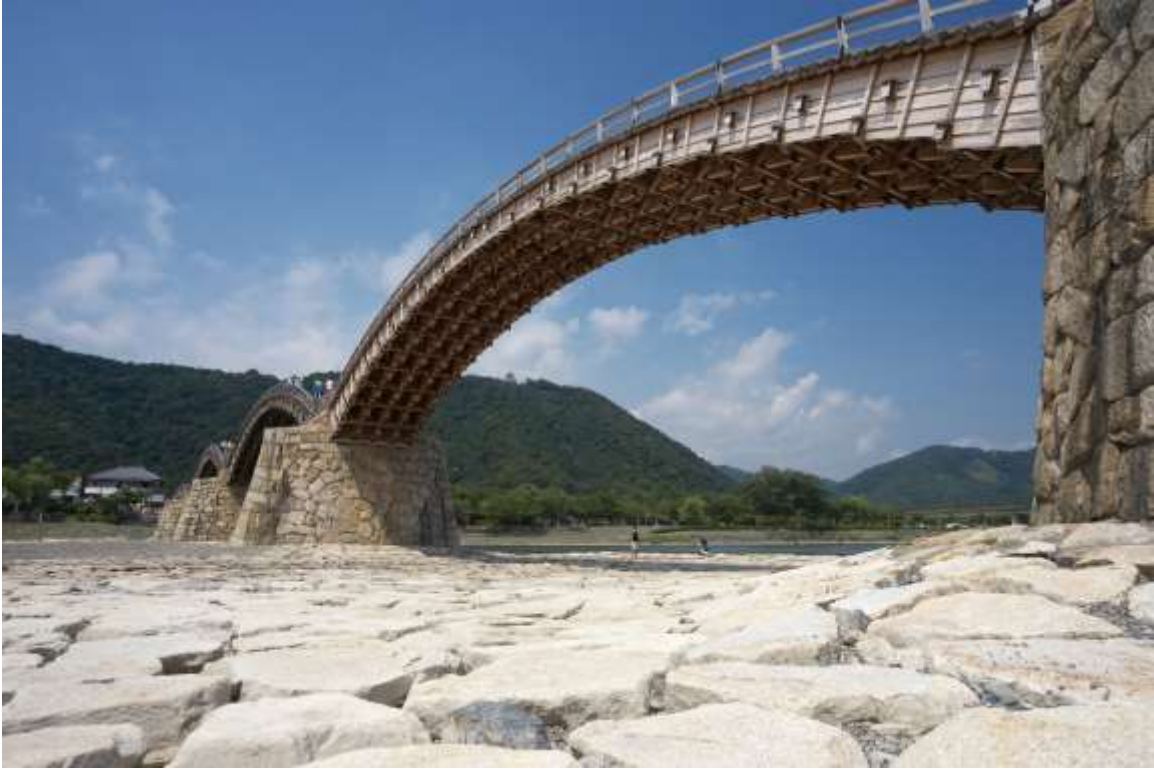
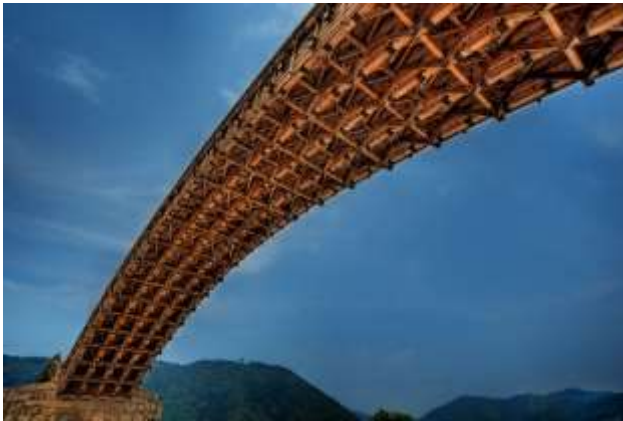
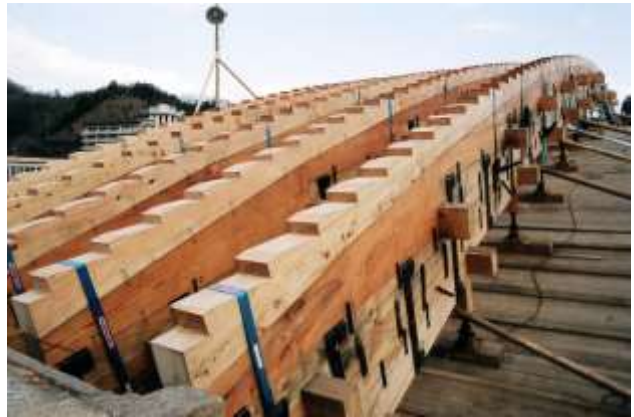
Figure 4-12: Kintai Bridge, spanning the Nishiki River in Japan, was originally constructed in 1673

The Kintai Bridge was originally constructed in 1673 spanning the Nishiki River in Japan, and has been restored and rebuilt a number of times since then. The bridge is made up of five wooden arches, each spanning approximately 35m (115ft). The arches consist of a unique leaf-spring style design, with multiple layers of timber joined together with iron straps. See Figure 4-12 below.

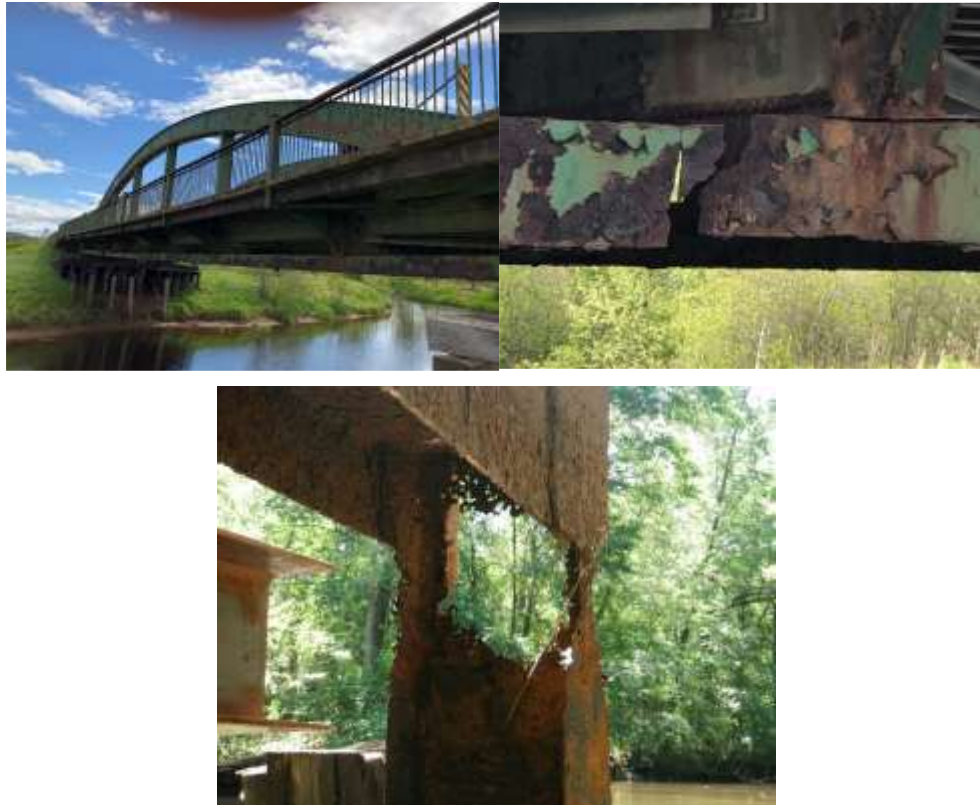
Figure 4-14: Photograph of the existing steel arch span that will be replaced by the new timber structure shown in Figure 4-13. Middle photograph shows the rusted through tension cords (out of service) in the old bridge that was less than 50 years old. Steel has not yet solved its rust problems with rust resistant steel particularly in marine environments where a patina of moisture that stays in place over prolonged periods. In such cases rusting of less than 25 year old elements like the bottom photo reveals have been found to occur. Bottom photograph of rust resistant steel in a railway bridge in Georgia near the coast. Wood doesn't rust!

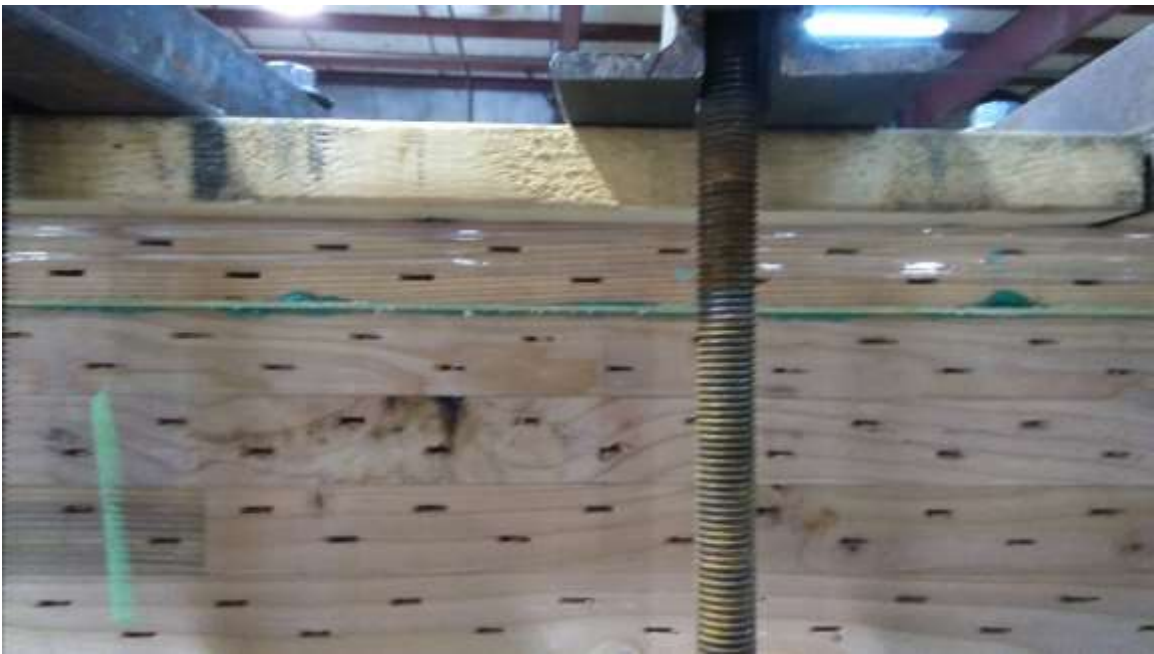
Figure 4-16: The glulam girders are reinforced with high-strength fiber on the tension face. This fiber-reinforcing is installed in the shop prior to assembling the structure.

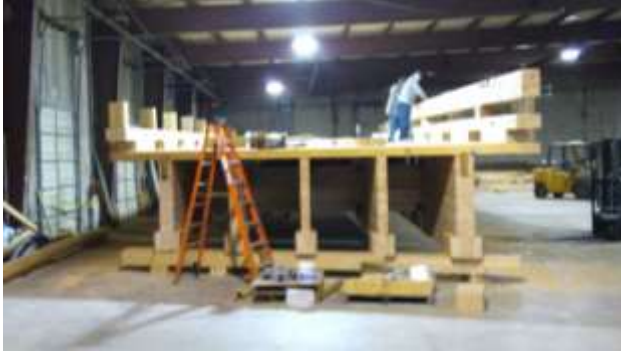
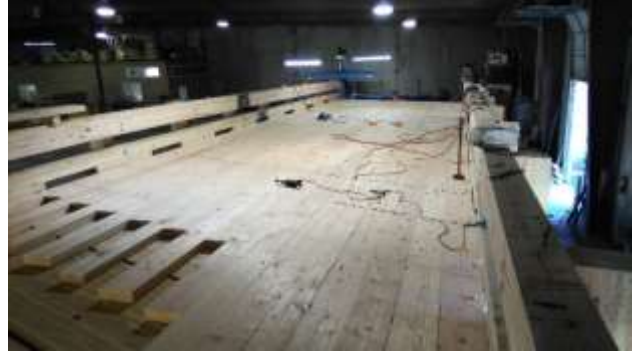
Figure 4-17: All timber components are fabricated and pre-assembled in the shop prior to preservative treatment. This dry-fit process helps avoid any field modifications that might compromise the preservative treatment layer. The bridge is then disassembled and the components are pressure-treated. They will later be shipped to the site for final assembly. The bridge incorporates an all timber TL4 truck crash proof rail system. The abutments are totally constructed of wood as well. The use of timber abutments versus concrete allows a much shorter construction period as there are no cure time issues relating to placement of the superstructure.

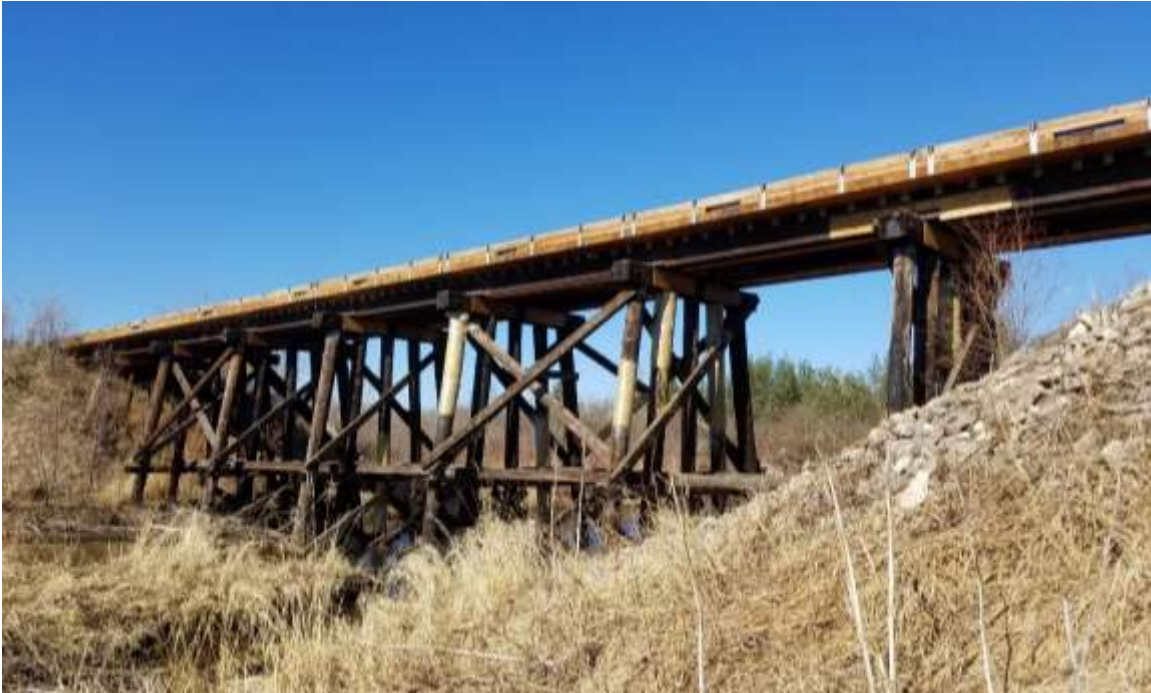
Figure 4-18: Meadow Lake Bridge is a conversion of a decommissioned railroad trestle to be used as a forestry bridge.

The restoration consisted of high-strength fiber-reinforcement of the existing stringers and substructure. Additionally, the existing railroad ties were replaced with a new transverse glulam deck and curb. See Figures 4-18 and 19 below.

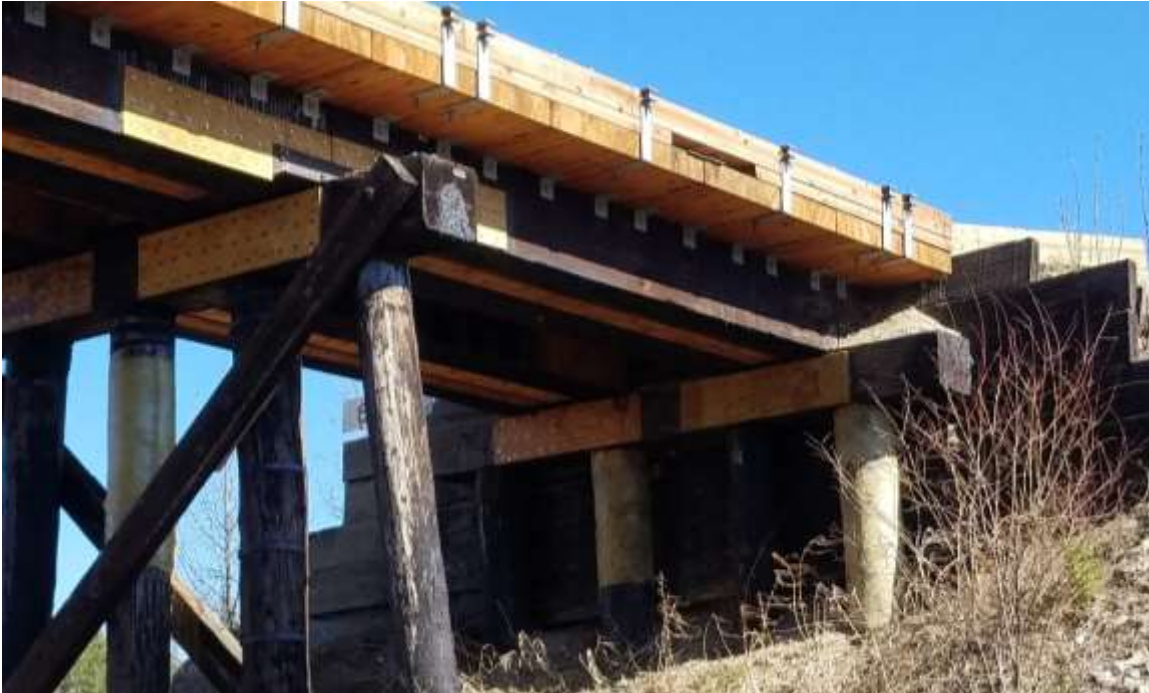
Figure 4-19: The Existing piles, caps, and chords were reinforced with high-strength fiber to restore capacity that had been lost due to decay. The old deck was removed and replaced with a new transverse glulam timber deck and curb.

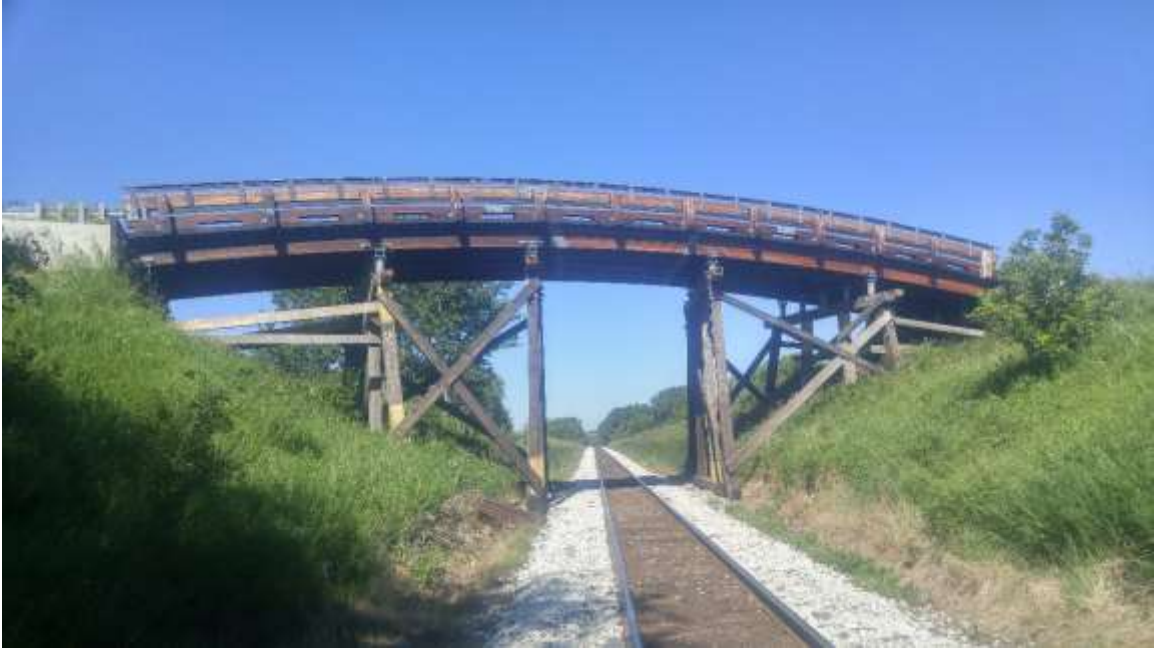
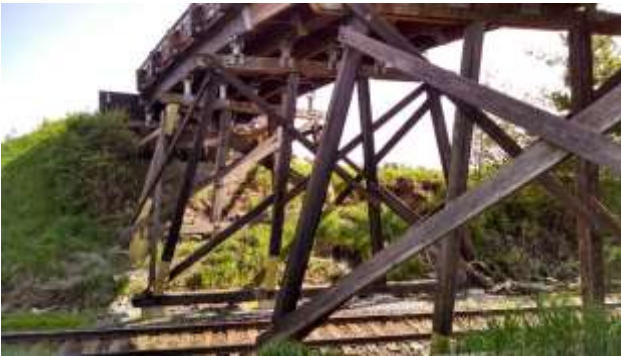
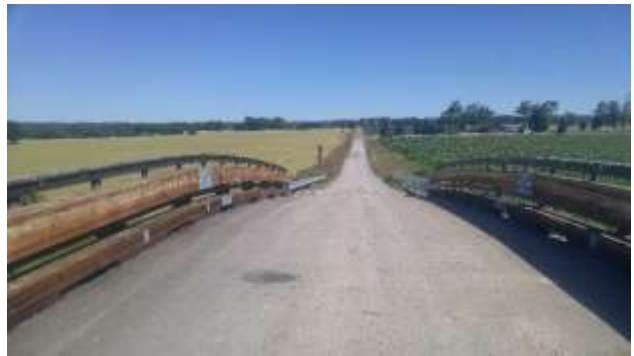
Figure 4-20: Providence Road Bridge in Clarington, Ontario consists of five lines of glulam girders supporting a transverse timber deck. The existing solid sawn frame bents were restored, including the addition of high-strength fiber reinforcing in some locations to restore capacity that had been lost due to decay. An asphalt wear surface was installed on top of the transverse timber deck. The timber guard rail is crash-tested to TL-4 specifications.

All three bridges are built on timber substructures. Providence Road and Snake Road both utilized significant portions of the existing substructure, while Dickinson had a full new substructure installed. The bridges all meet the loading requirements of Ontario CL625 loading (S6-14). See Figures 4-20 to 22.

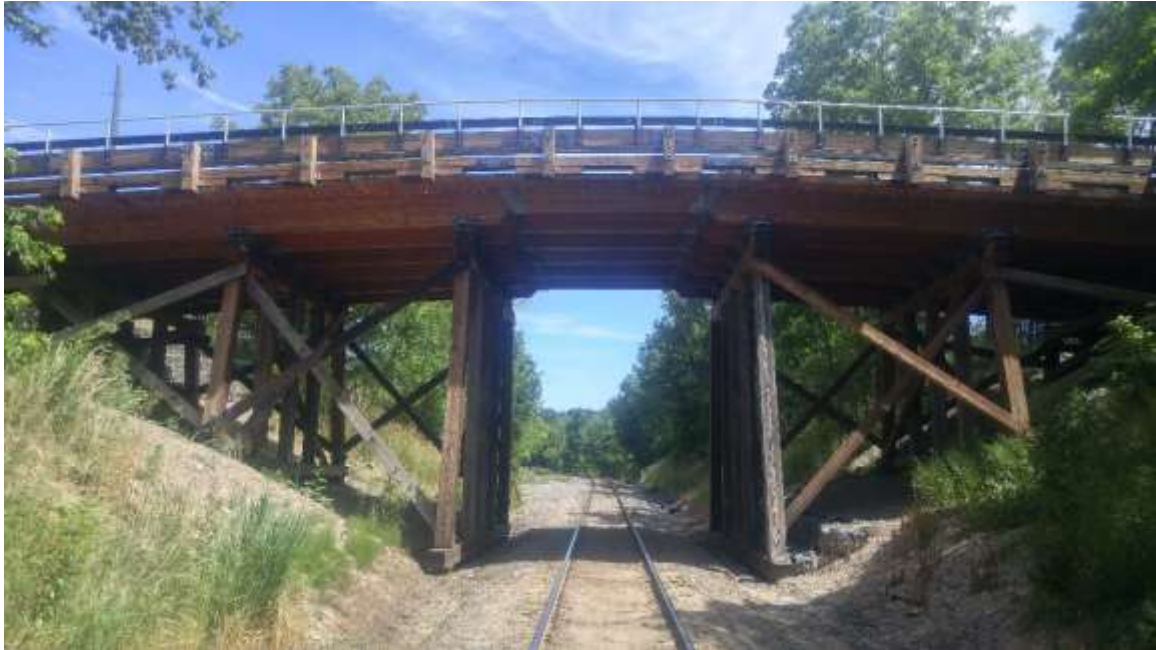
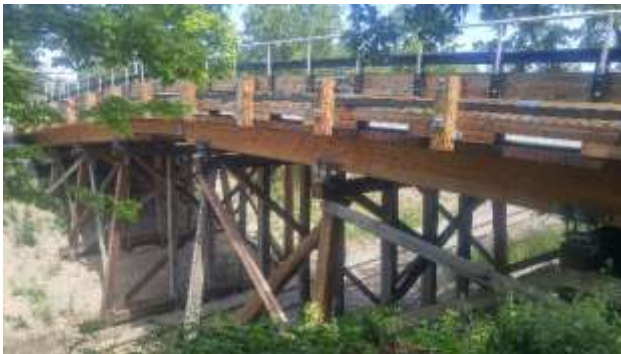
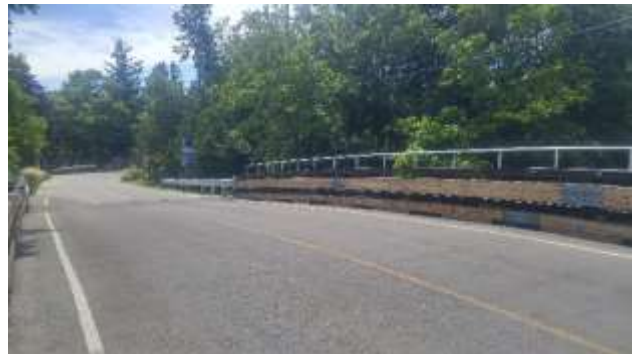
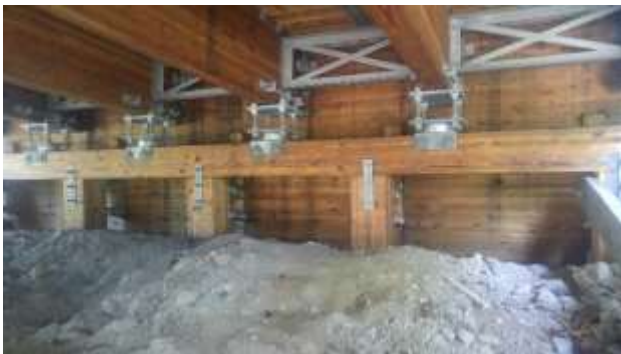
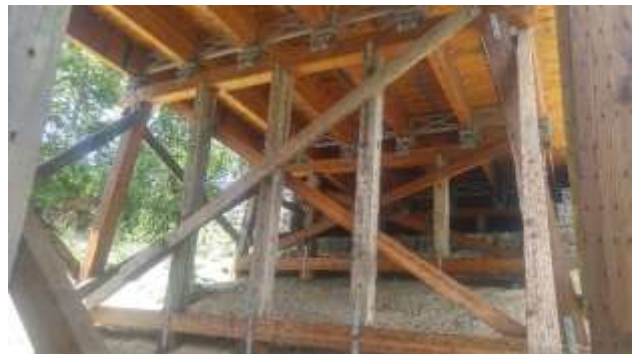
Figure 4-21: Snake Road Bridge, on the border between Hamilton and Burlington, Ontario, consists of six glulam girder lines. The substructure was completely rebuilt; however, much of the material from the original structure was salvaged for use in the new bridge. The substructure was completely timber and the highway was designed for two lane heavy truck use beyond a conventional CL625 rating. It also incorporated an all timber TL4 truck crash proof rail system.

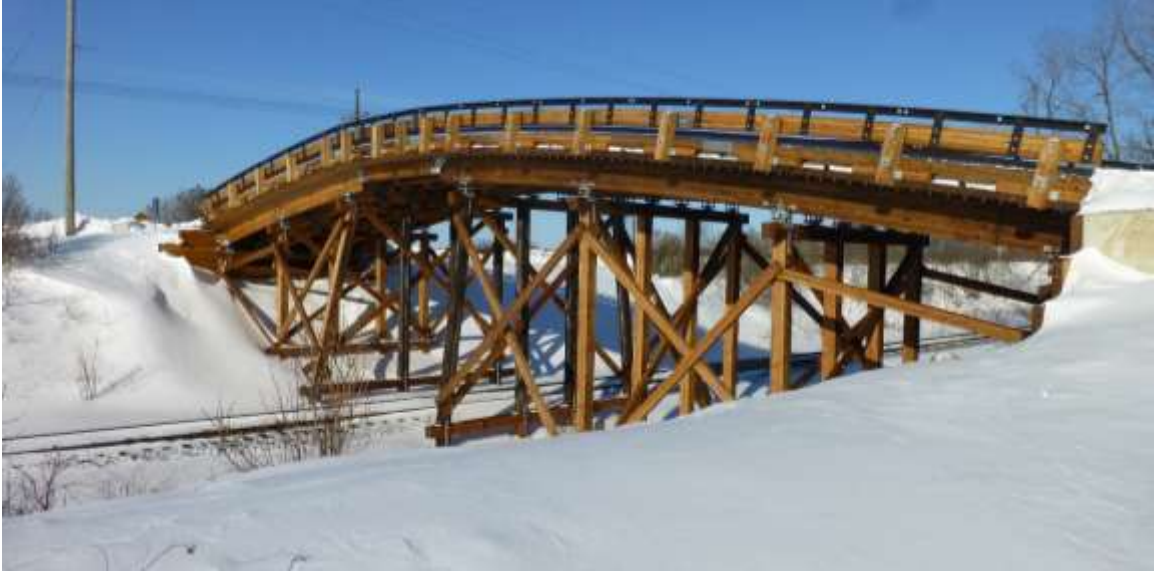
Figure 4-22: Dickinson Road Bridge, in Port Hope, Ontario consists of six glulam girder lines. The substructure was completely rebuilt; however, much of the material from the original structure was salvaged for use in the new bridge.

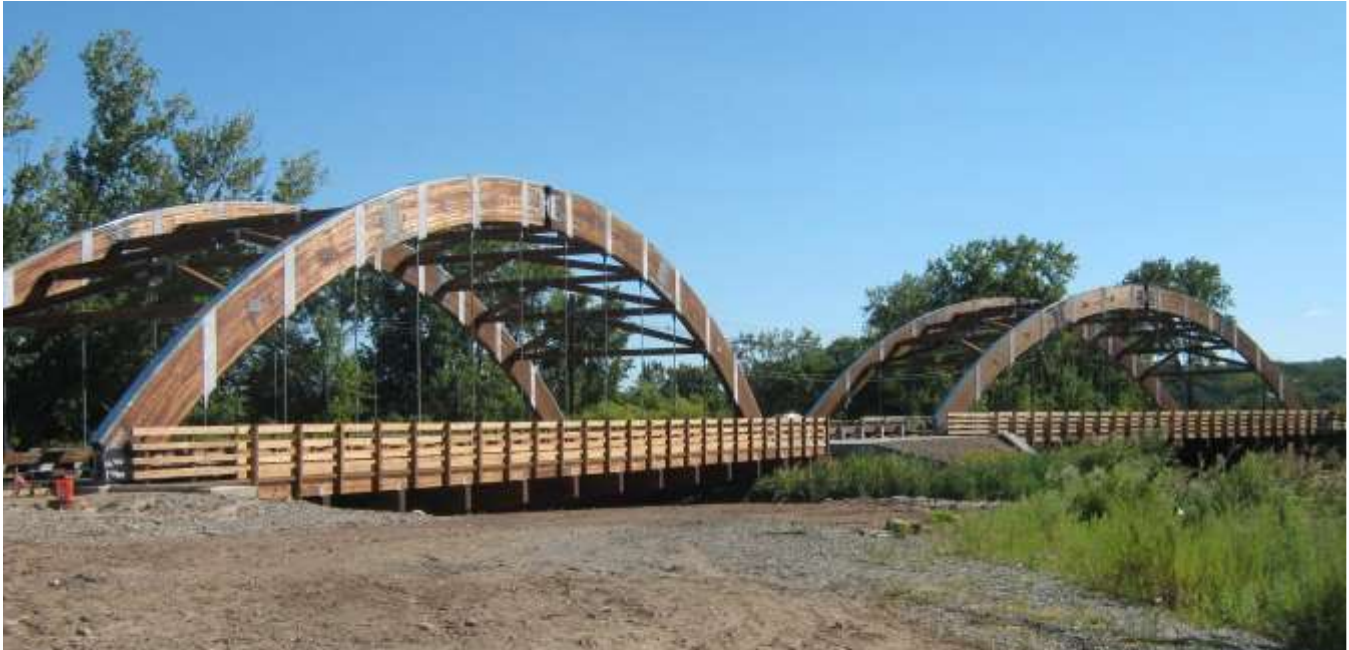
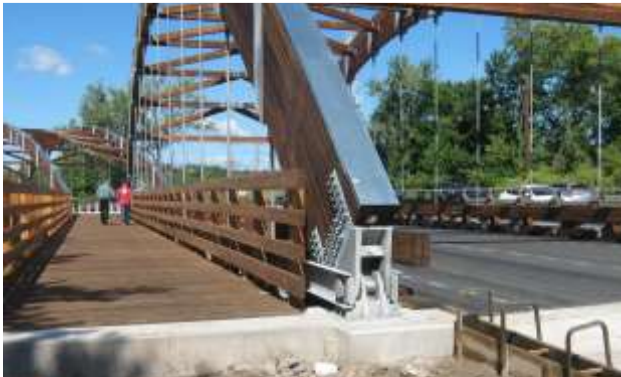
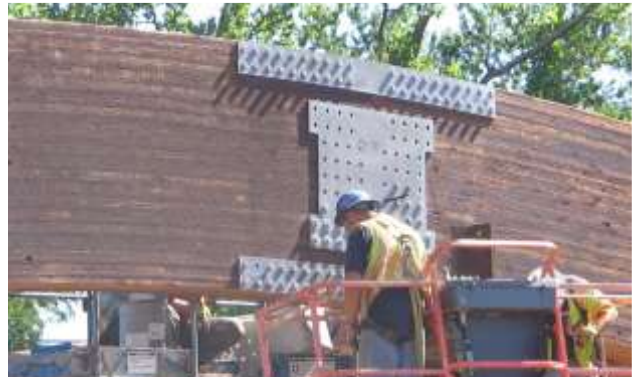
Figure 4-23: Overpeck Park Bridges, by Western Wood Structures, are a pair of two identical through-arch bridges. Each bridge spans 43m (140ft) and carries two lanes of traffic and a pedestrian walkway. The arches are three-pin arches, with a hinge at mid-span; to reduce the size of the individual members, each arch segment is broken into two pieces with a moment splice at its midpoint.

The Overpeck Park Bridges, designed and built by Western Wood Structures, in Teaneck, New Jersey is a pair of glulam through-arch bridges, each with a span of 43m (140ft) and a roadway width of 9m (30ft) plus a walkway of 3m (10ft) on one side (Gilham, 2013). HS20 loading as per ASHTO. See Figure 4-23 below.

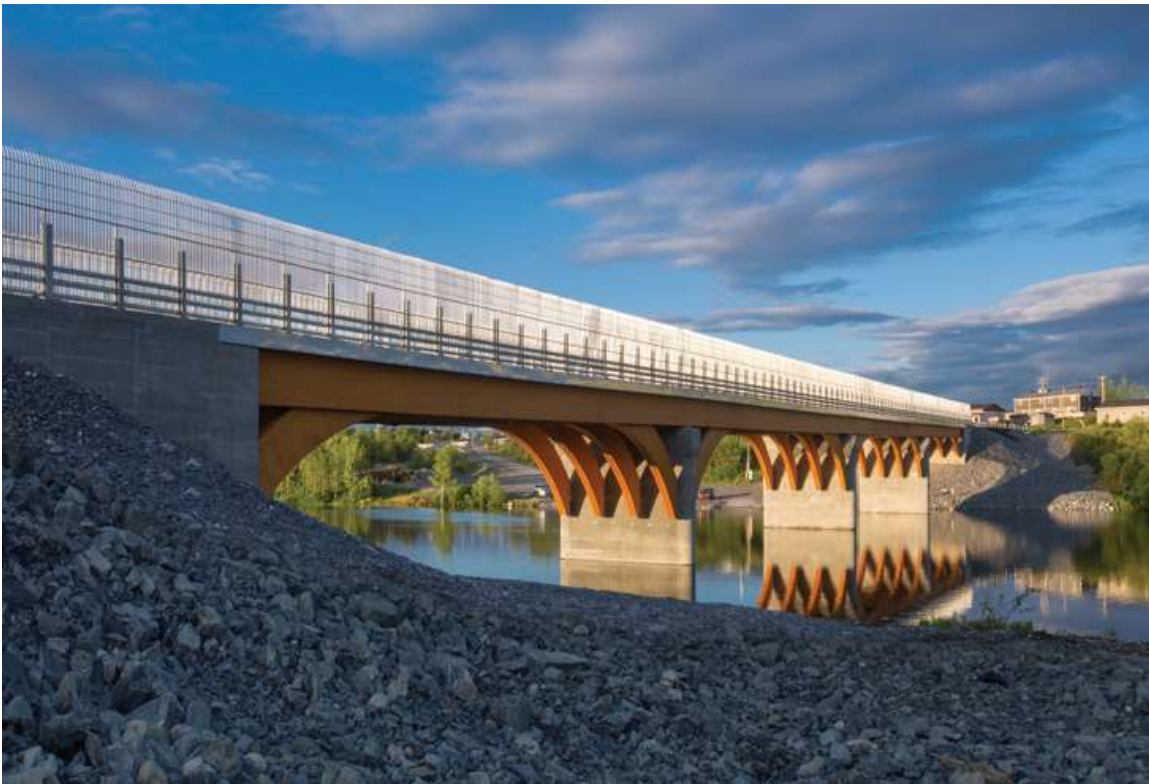
Figure 4-24: Mistissini Bridge is a 4-span bridge totaling 160m (525ft) long. The bridge is 9.25m (30ft) carrying two lanes of traffic, plus a pedestrian walkway on one side. It consists of glulam girders and arched knee-braces supporting a glulam deck with an asphalt wear-surface. (Forestric Nordic, 2015)

The engineering team developed the timber design in parallel with a conventional steel and concrete design. It was found that the timber option was slightly less expensive than the concrete and steel option, largely due to the reduced transportation costs. A carbon study was also conducted to compare the greenhouse gas emissions from each of the design options. It was found that the timber option had net-negative carbon footprint equivalent to -497 tonnes of CO₂ emissions. By comparison, the steel and concrete option would have generated 969 tonnes of CO₂ emissions (Lefebvre & Richard, 2014). See Figure 4-24 and 25 below.
