**Wood Research
& Development**

Viability of Modern Timber Highway Bridges

Chris Legg, Architect, Senior CAD and Report Specialist

Dan Tingley, Senior Timber Structures Engineer/Wood Technologist, PhD | PEng (CA) | MIEAust | CPEng | RPEQ (AU)

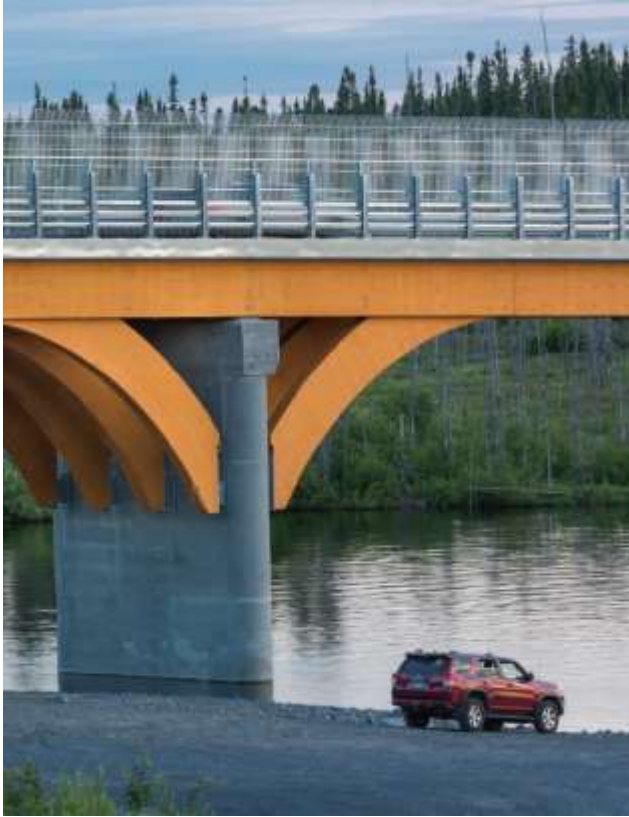
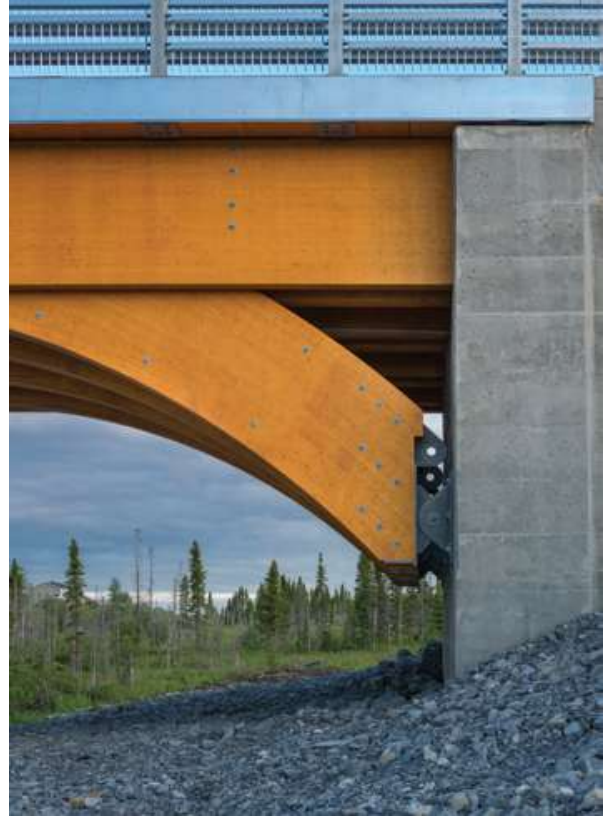
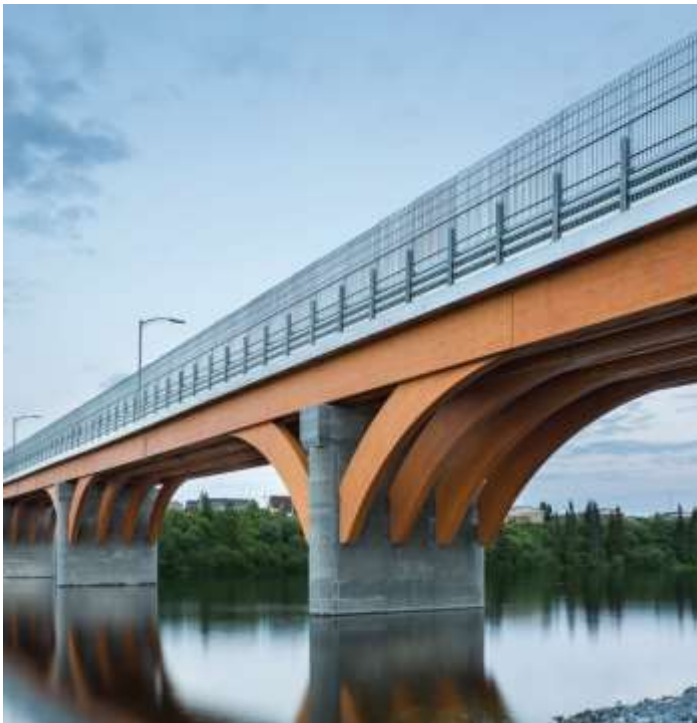
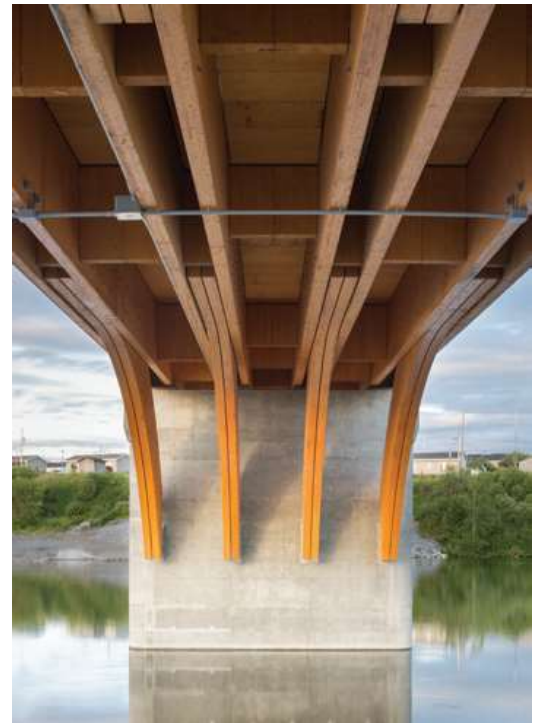
Figure 4-25: The arched braces are connected to the piers with pinned connections. The connection between the arches and the girders serves to both support the girder ends and to create a moment-resisting splice in the girders. This forms a continuous structure with no deck joints, which will help avoid cracking of the asphalt and maintain a waterproof surface. (Forestric Nordic, 2015)

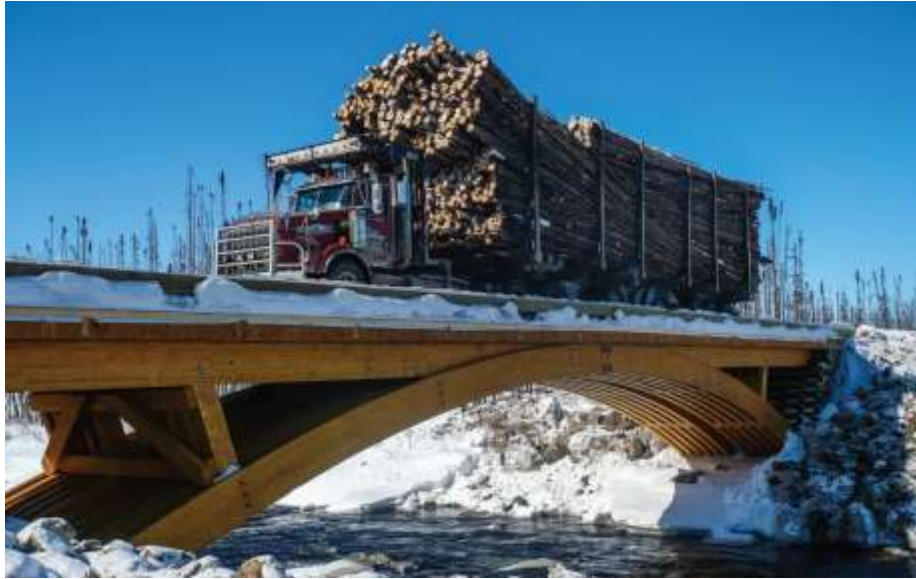
Figure 4-26: Tamiscame River Bridge, by Nordic Structures, consists of 12 glulam arches spanning 30m (98ft) which support 10 glulam girders and a transvers glulam deck. (Forestrie Nordic, 2015)

Built in 2009 by Nordic Structures, Tamiscame River Bridge is a forestry bridge (L100 as per S6-14) in Quebec supported by a glulam arch-under system. The arches span 30m (98ft) and the total deck length is 34m (112ft). (Forestrie Nordic, 2015). See Figure 4-26 below.

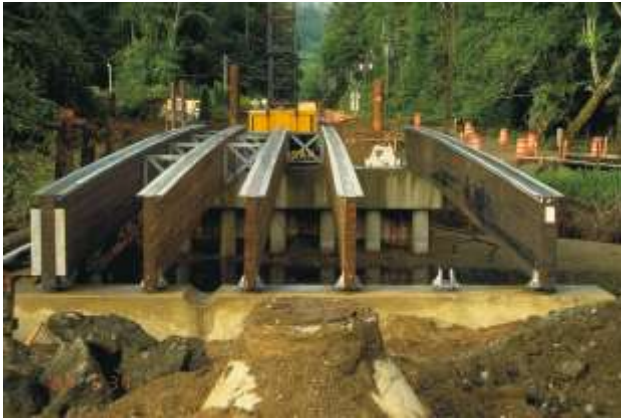
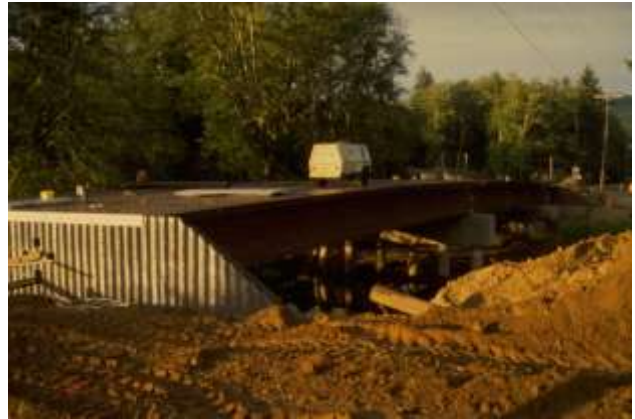
Figure 4-27: The Lighthouse Bridge, under construction in Clallam Bay, Washington. The bridge consists of six fiber-reinforced glulam girders in each span.

The Lighthouse Bridge near Clallam Bay, Washington is a 2-span, 50m (160ft) bridge consisting of fiber-reinforced glulam girders and a transverse glulam deck. Constructed in 1995, the Lighthouse Bridge was the first vehicular bridge designed for heavy loading (HS25-44) to utilize FiRP® Reinforcing in the United States (Tingley & Gai, 1998). Figures 4-27 and 28 below.

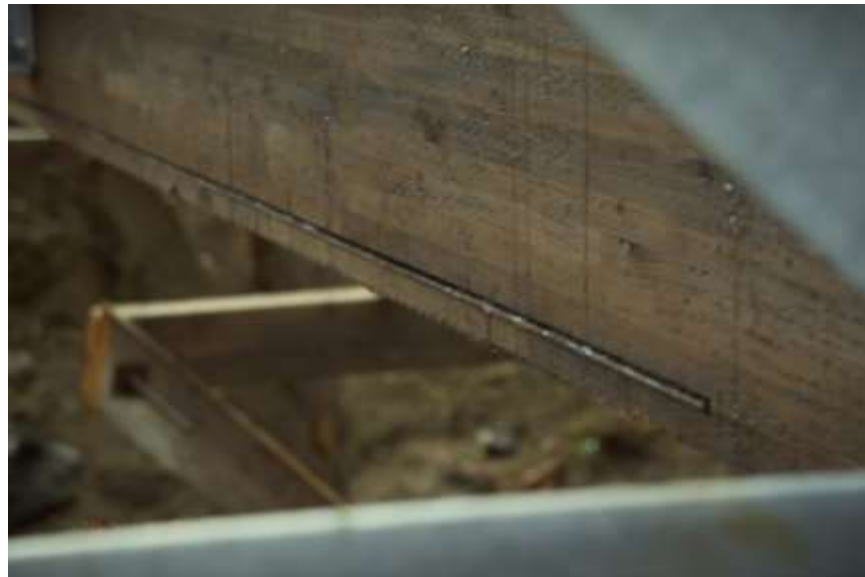
Figure 4-28: The glulam girders are reinforced with a layer of fiber-reinforced polymer (FiRP®) which permitted a significant reduction in the volume of wood required compared to an unreinforced bridge. This bridge has been in service since the early 1990's.

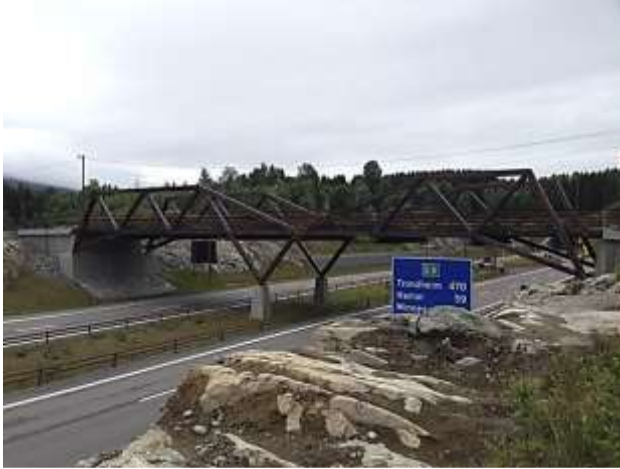
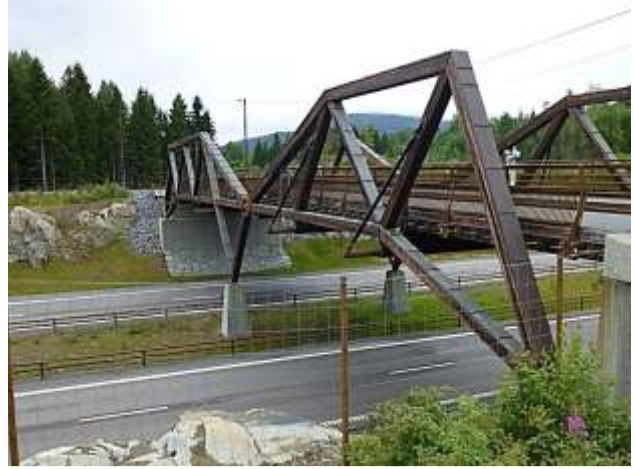
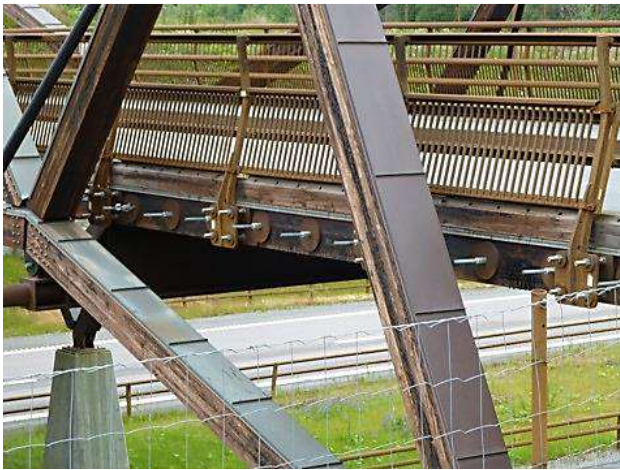
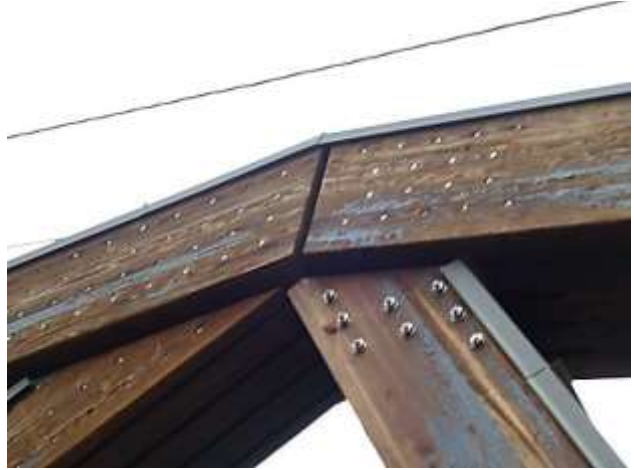
Figure 4-29: Sletta Bridge in Eidsvoll, Norway. The structure consists of asymmetrical glulam trusses which carry steel crossbeams and a stress laminated deck. In addition to being dual preservative treated (with a copper-based preservative and creosote) the main elements are sheltered from moisture using metal flashing.

Sletta Bridge, in Eidsvoll, is a 2-span, 47.7m (157ft) bridge featuring unique, asymmetrical glulam trusses. These trusses carry steel crossbeams supporting a longitudinal stress laminated deck. The glulam timbers were dual-treated – first the individual lamina were treated with a copper based preservative, then, after fabrication, the finished components were treated with creosote. See Figure 4-29 below.

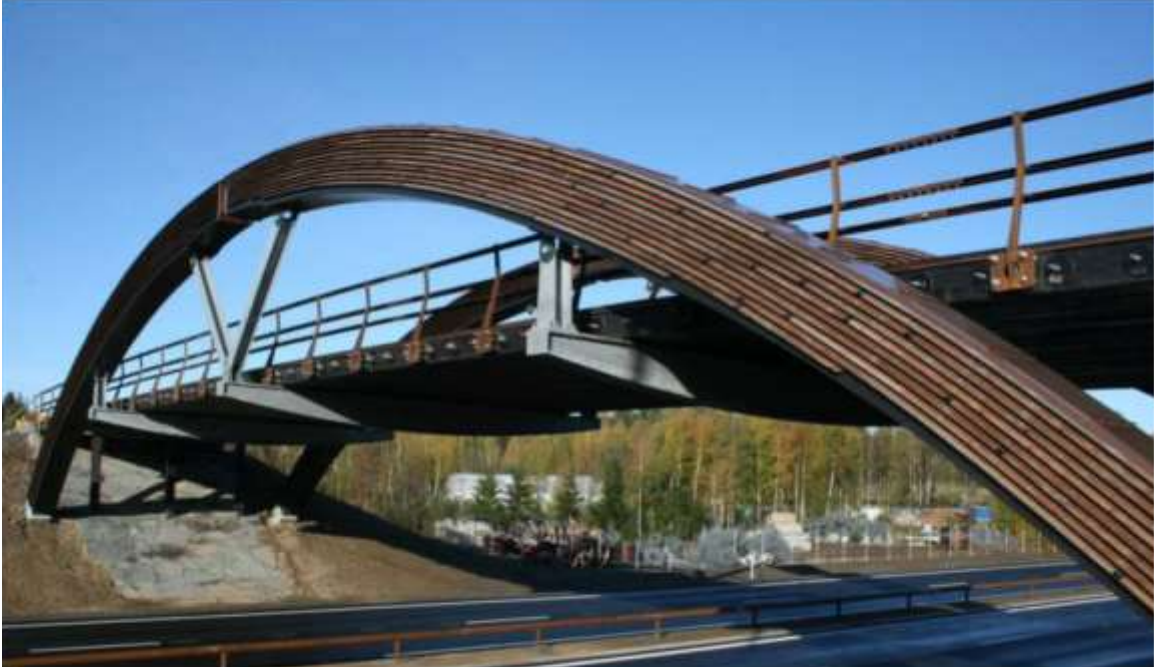
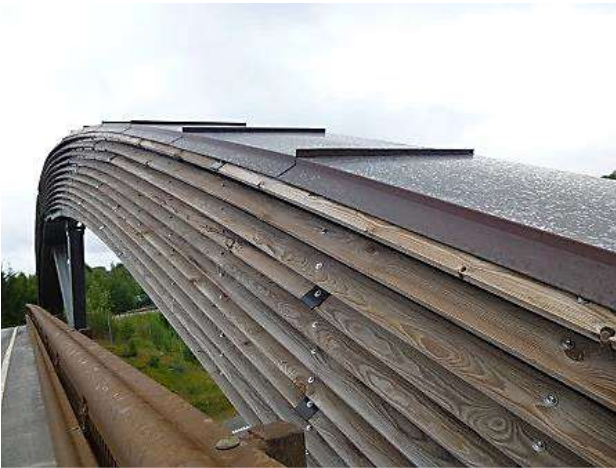
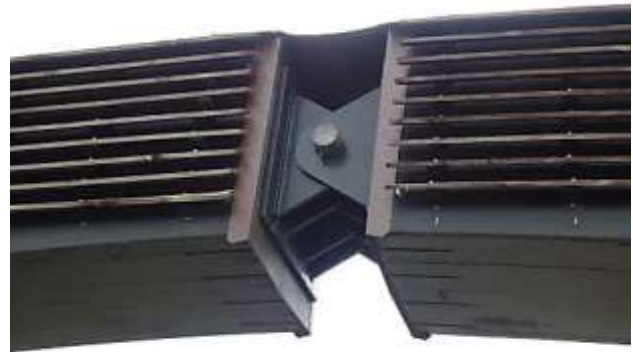
Figure 4-30: Skogsrud Bridge in Tangen, Norway consists of two glulam arches and a stress-laminated deck. The arches are protected with metal flashing on top and wood louvers on the vertical faces. This shelters the elements from rain while still allowing sufficient air flow to keep the moisture content of the wood low.

Skogsrud Bridge, in Tangen, is an overpass crossing a 4-lane highway, with a main span of 37m (122ft) and a total length of 49m (160ft). The structure consists of glulam, three-pinned arches supporting steel crossbeams and a stress-laminated deck. The arches are sheltered from rain by metal flashing on top and wood louvers on the vertical faces. See Figure 4-30 below.

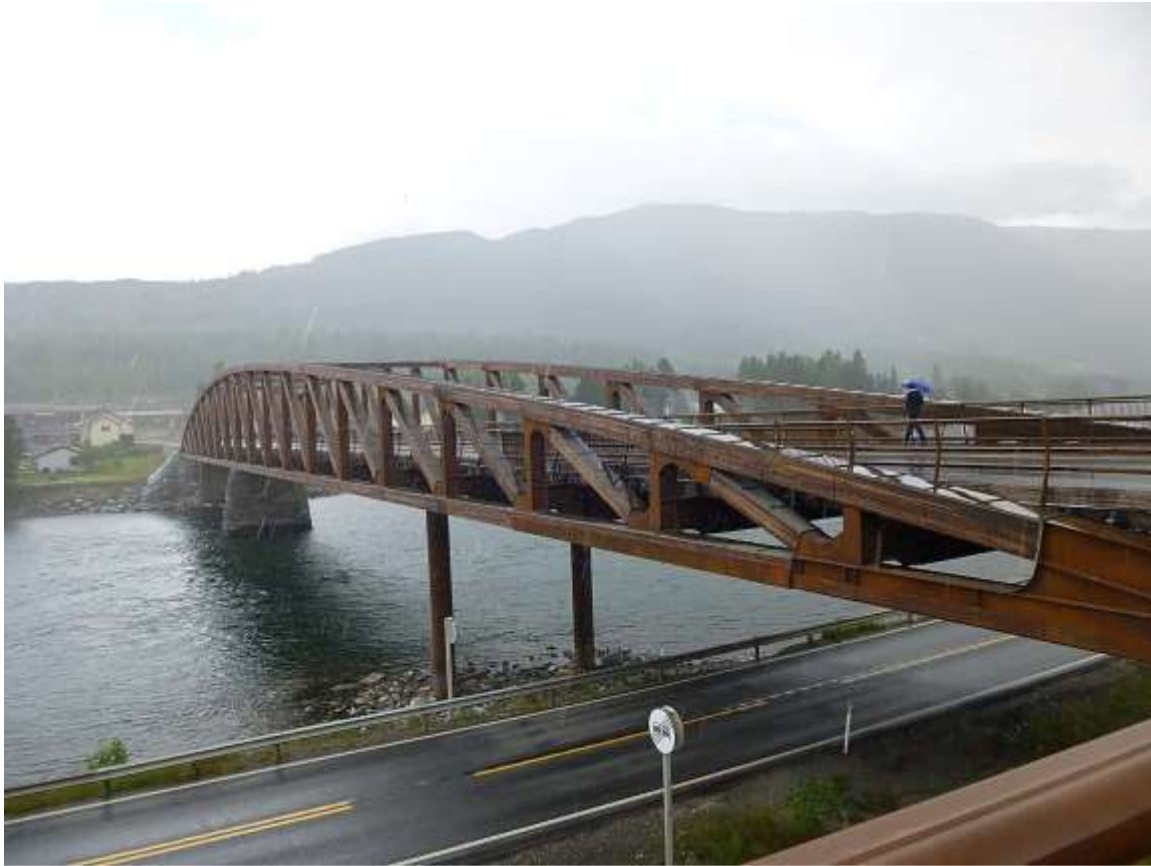
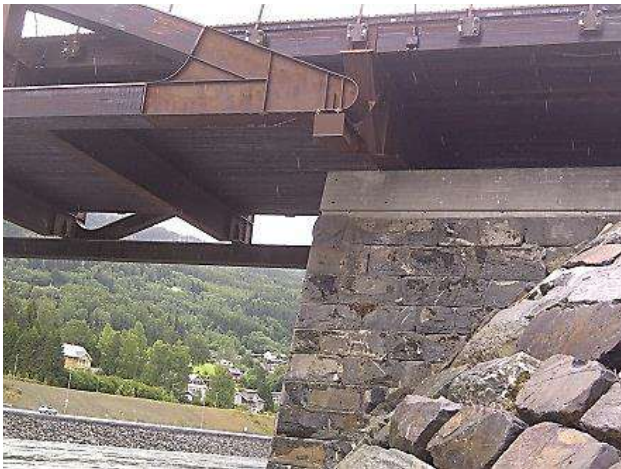
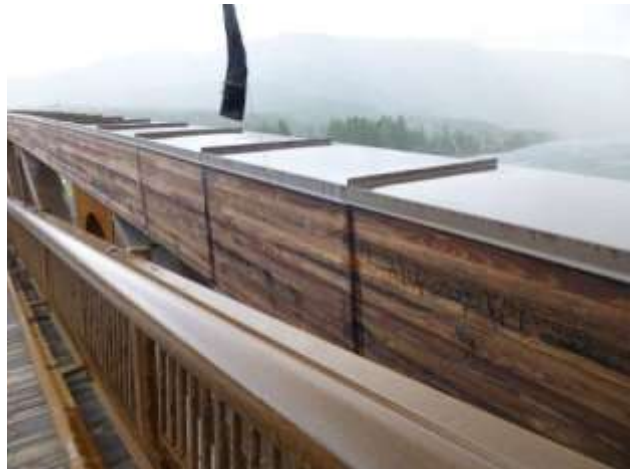
Figure 4-31: Tretten Bridge is a continuous truss across three spans. The truss is a hybrid truss made primarily from glulam timbers with steel vertical web members and steel shoes at the nodes. Corten weathering steel was used for the steel elements.

Tretten Bridge is a two-lane three-span bridge with a total length of 148m (485ft) and a longest span of 70.2m (230ft). The bridge replaced an existing steel bridge, and utilized the original concrete abutments and piers. See Figure 4-31 below.

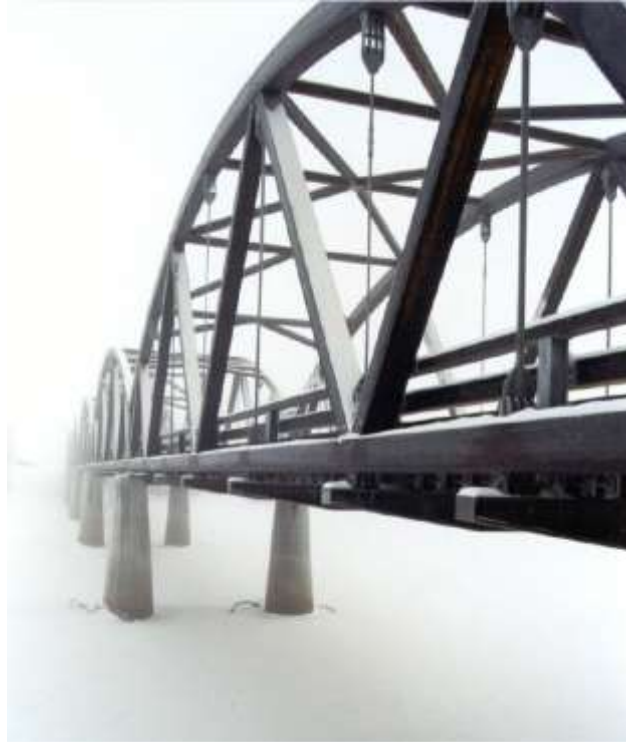
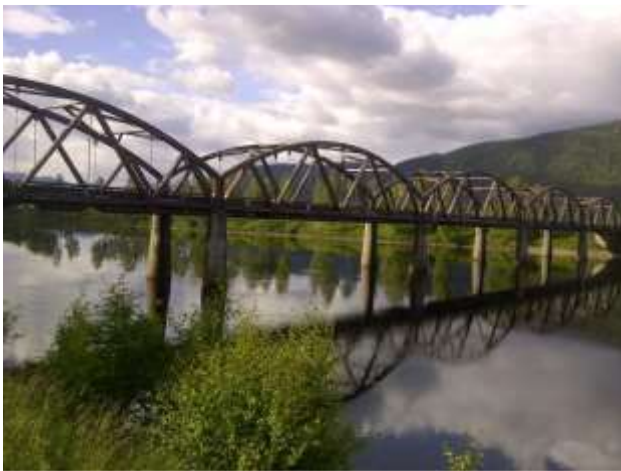
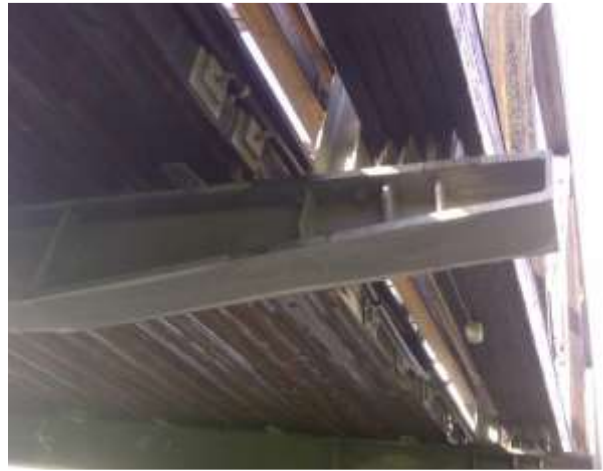
Figure 4-32: Evenstad Bridge is made up of five glulam truss spans, each 36m (118ft) long. The trusses support steel cross beams and a stress-laminated deck.

Evanstad Bridge is a five-span, 180m (590ft) bridge. Each 36m (118ft) span consists of a pair of arched glulam trusses. These trusses carry steel crossbeams and a longitudinal stress-laminated deck.

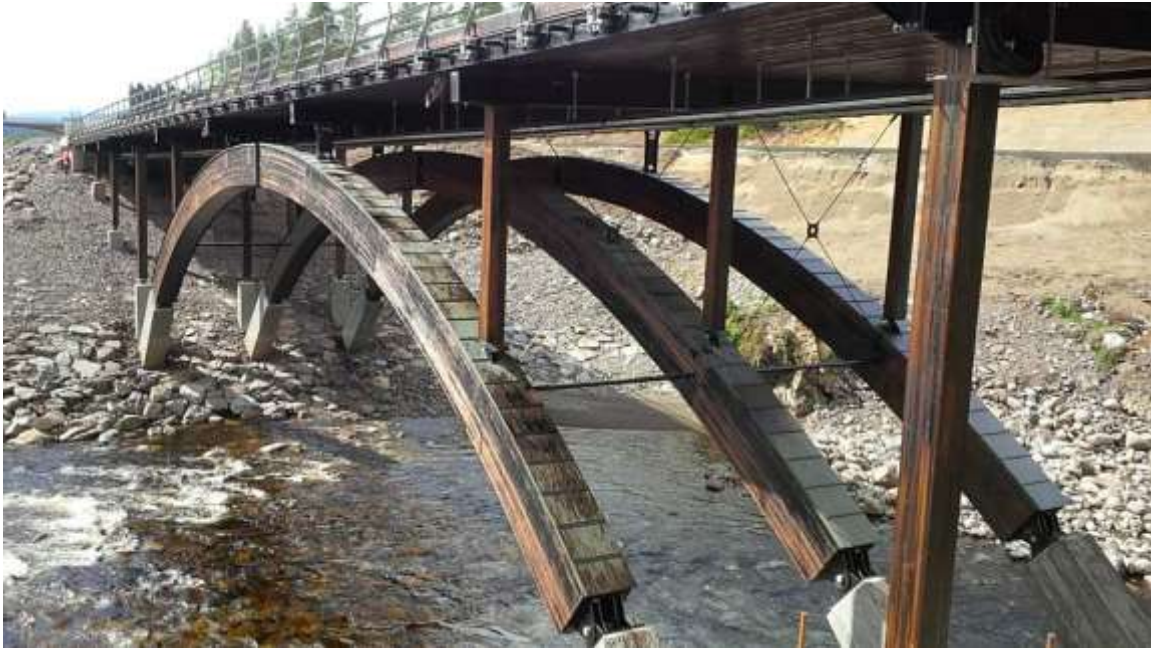
Figure 4-34: Asta Bridge is a stress laminated deck supported by glulam arches. The deck totals 96.6m (317ft), and the arches span 38.5m (126ft).

Asta Bridge, in Rena, is a longitudinal stress laminated deck supported on steel crossbeams. The deck totals 96.6m (317ft). The central span of 38.5m (126ft) is supported by glulam arches. See Figure 4-34 below.

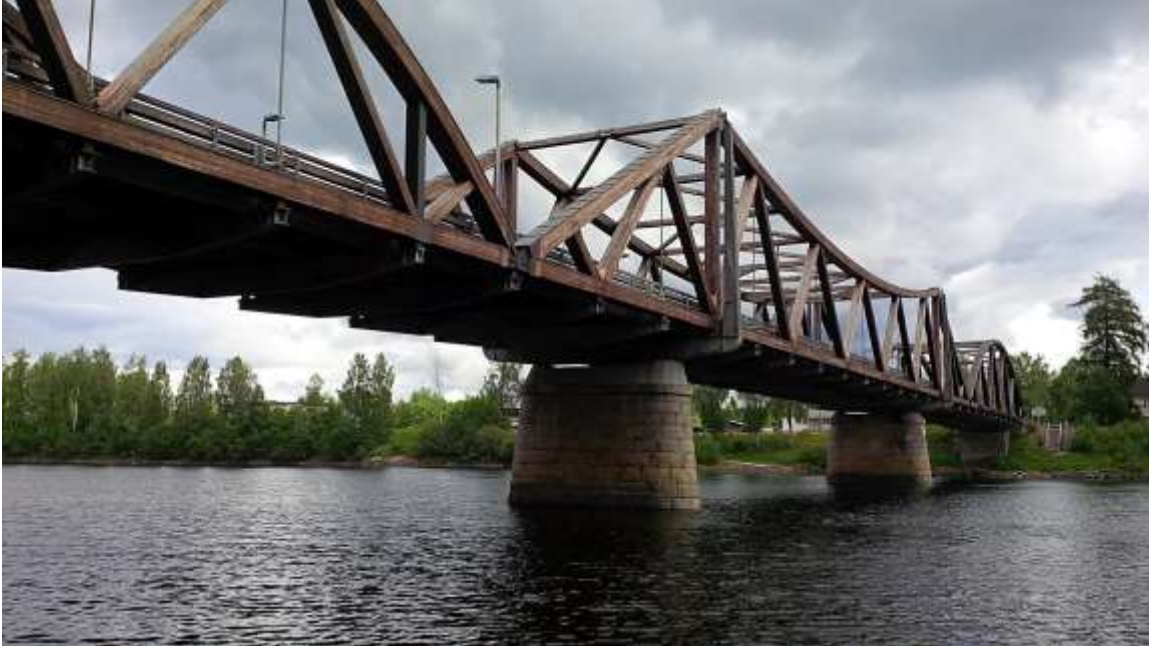
Figure 4-35: Flisa Bridge is a three-span glulam truss bridge totaling 196m (643ft) with a maximum span of 70m (230ft).

Flisa Bridge is a three-span glulam truss bridge totaling 196m (643ft) with a maximum span of 70m (230ft). The trusses carry steel cross beams and a stress laminated deck. See Figure 4-35 below.

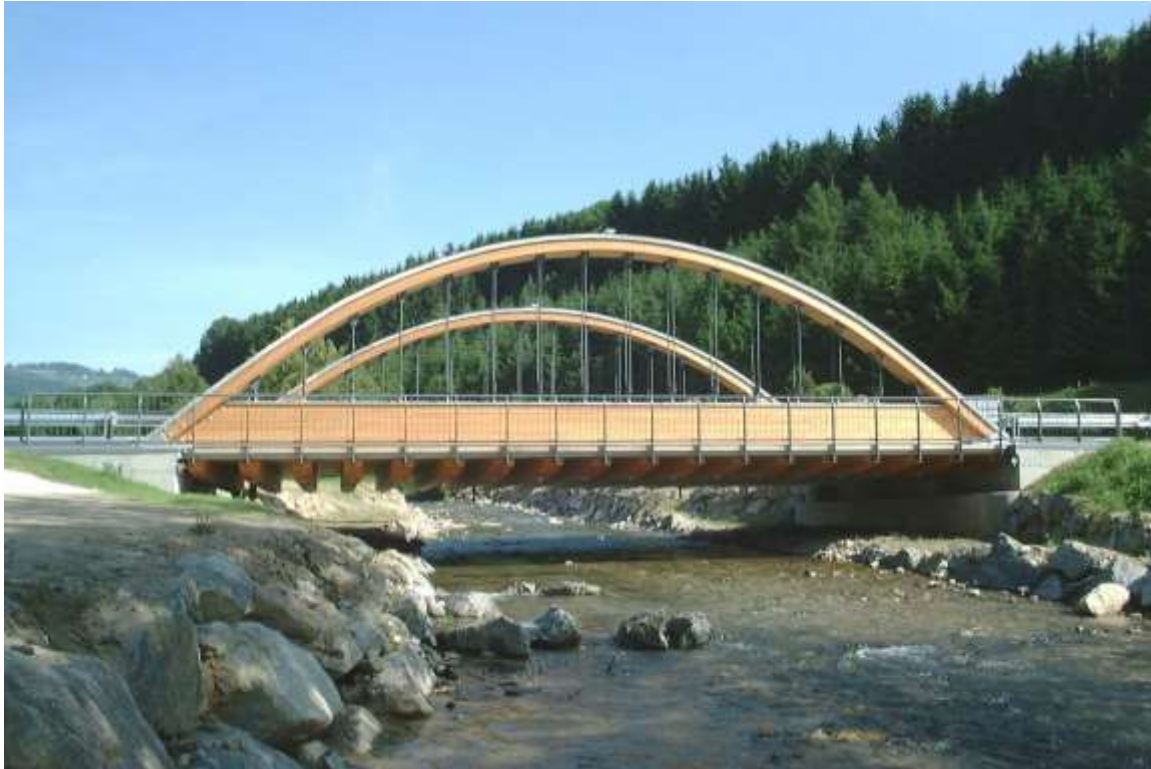
Figure 4-36: Krystalbrücke consists of two glulam tied-arches. These support steel hangers which carry the transverse glulam beams which, in turn, carry the deck. This bridge has been in service since 1995.

Krystalbrücke is a tied-arch glulam bridge in Treffen, Austria. The arches carry transverse glulam beams which, in turn, support a cross-laminated timber deck. The bridge carries two lanes of traffic and a sidewalk and is designed for 60 ton vehicle loads. See Figure 4-36 below.

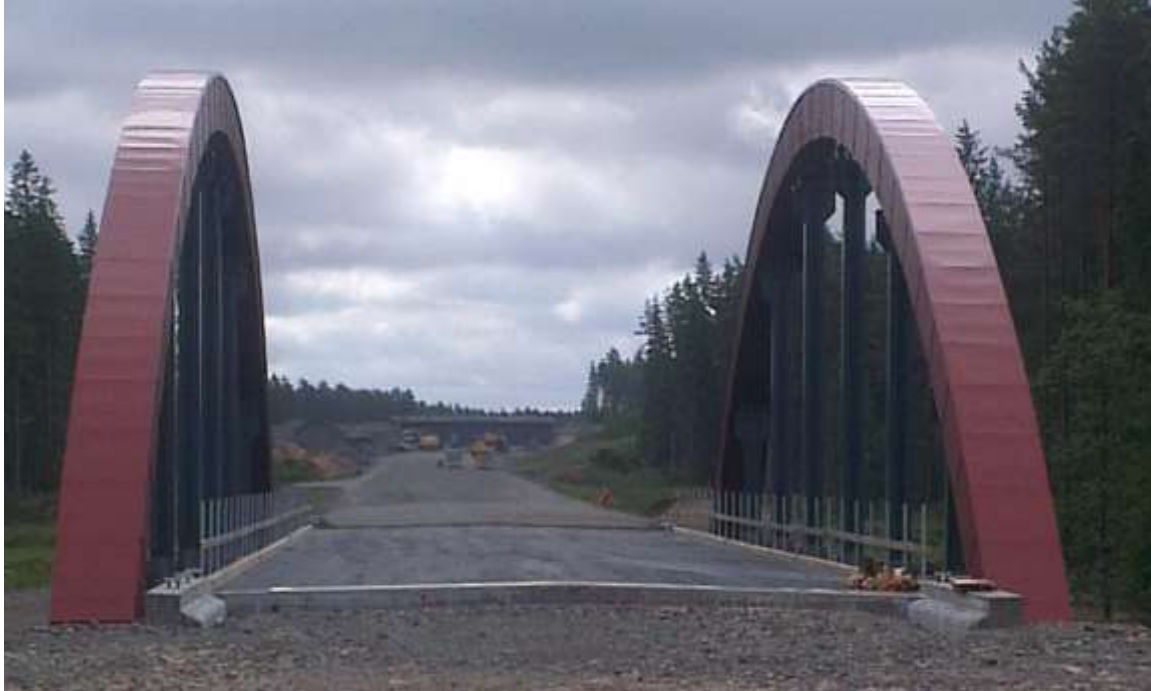
Figure 4-37: Nissan River Bridge spans 47.4m (155ft) and consists of two three-pinned arches. The arches carry steel hangers and crossbeams which in turn carry a stress-laminated deck. The glulam arches are sheltered by steel flashing on top and vented wood panels on the vertical faces.

At 47.4m (155ft) Nissan River Bridge is the longest single-span timber highway bridge in Sweden. It consists of two three-pinned arches which carry steel cross beams and a longitudinal stress-laminated deck. Lateral stability of the arches was achieved by using stiff steel hangers and moment resisting connections from the arch to the hangers and from the hangers to the crossbeams (Ekholm, Nilson, & Johansson, 2013). See Figure 4-37 below.

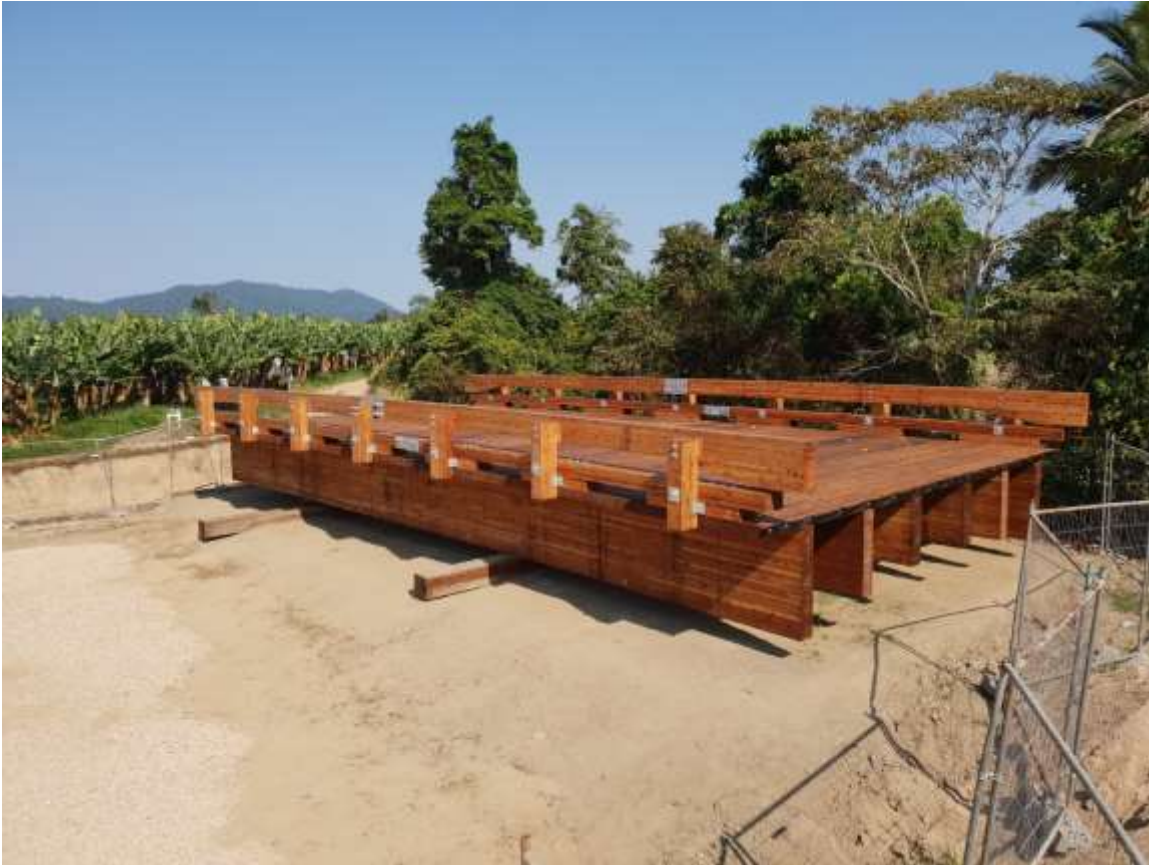
Figure 4-38: Cowley Creek Bridge, fully assembled and ready to be installed as soon as the foundation upgrades are completed.

Cowley Creek Bridge is a 16.5m (54ft) two-lane bridge made up of glulam girders, transverse glulam deck, and a timber guard rail rated to TL-4 crash test standards. The bridge is a replacement for an existing structure. The superstructure and deck were fully assembled adjacent to the roadway. After the

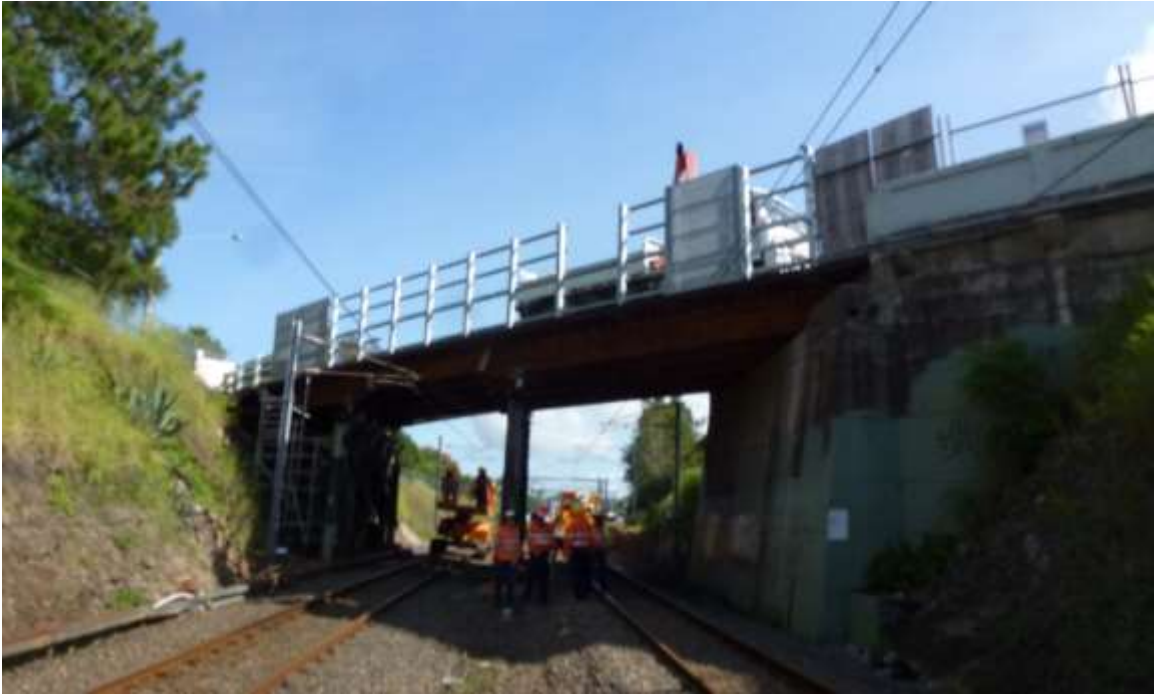
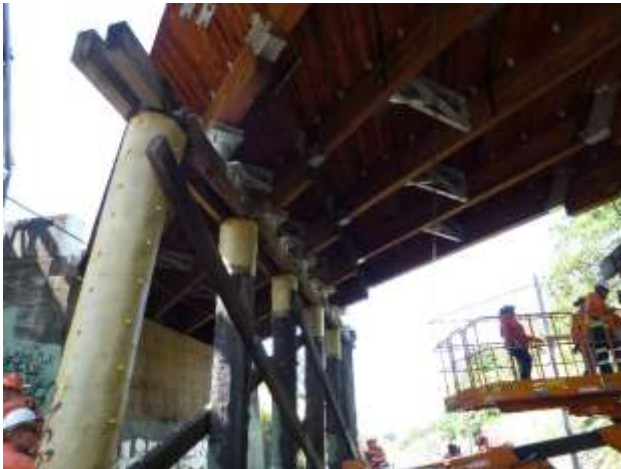
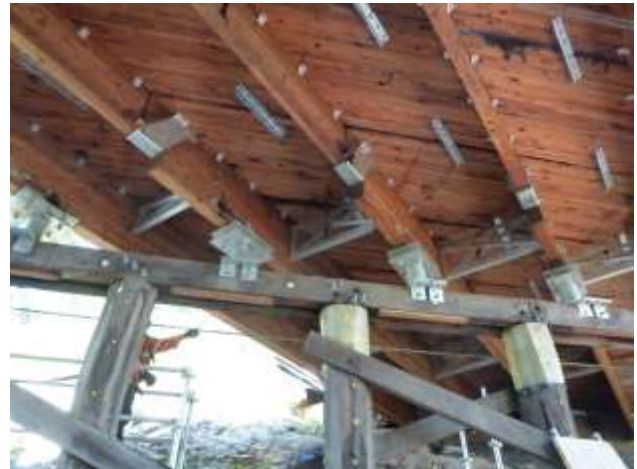
Figure 4-39: Alderley Avenue Bridge crosses a pair of Queensland Rail tracks. The new glulam superstructure and deck were installed on the existing substructure. Localized decay in the substructure was repaired using high-strength fiber wraps on the piles and tension reinforcement on the headstocks. This bridge was installed in 39.5 hours. From the start of design phase to the completion of works was 65 days.

Boundary Road Bridge and Alderley Avenue Bridge are overpass bridges crossing Queensland Rail tracks near Brisbane. Both bridges consist of glulam girders supporting transverse glulam deck panels. The bridges were replacements for existing overpasses, and the existing timber substructures were restored using high-strength fiber to carry the new bridges. The lightweight timber superstructures allowed rapid installation that minimized interruptions to rail traffic below. Both bridges were designed to 44T loading as per AS5100. See Figure 4-39 and 40 below.

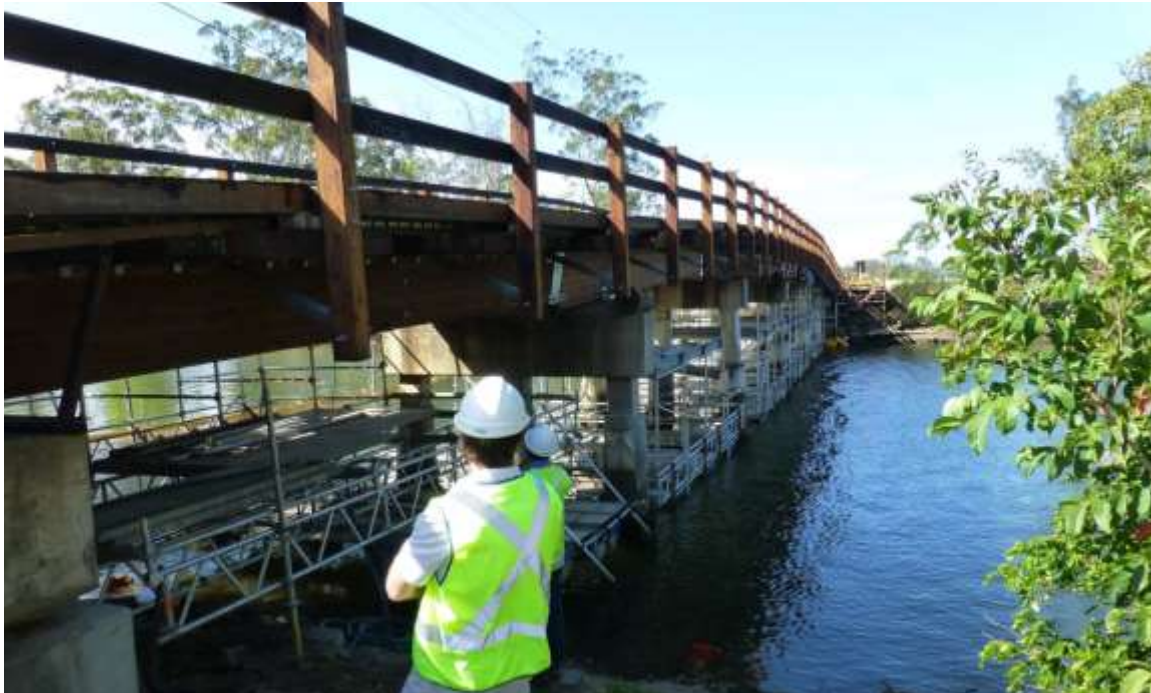
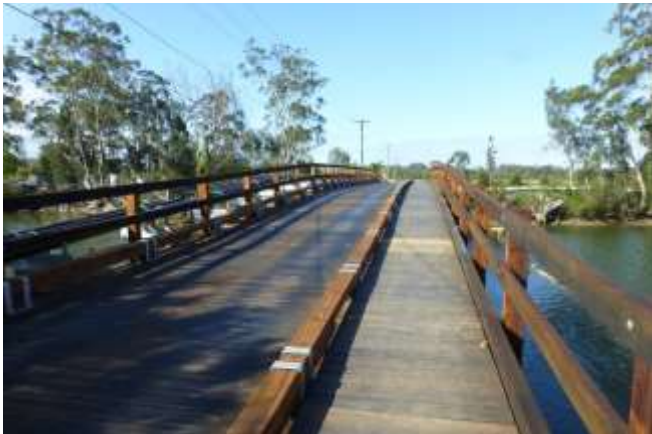
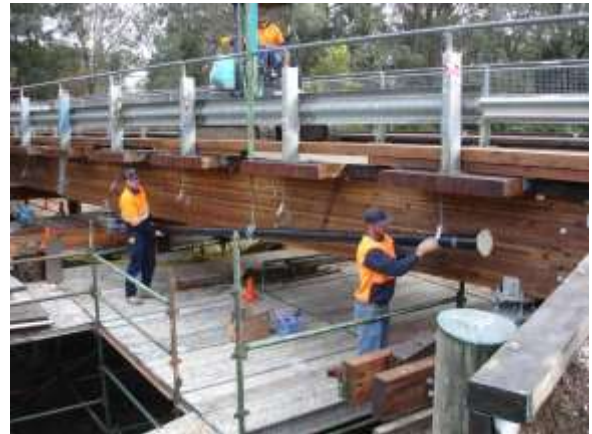
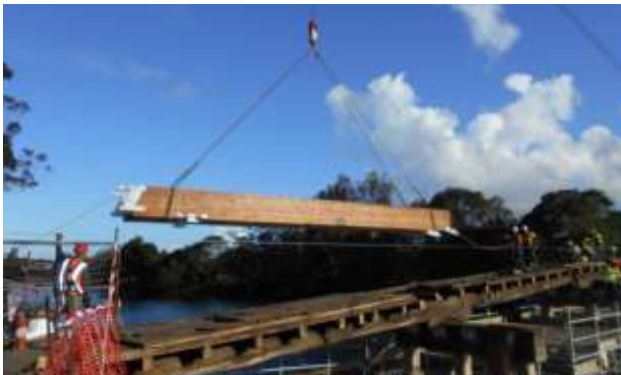
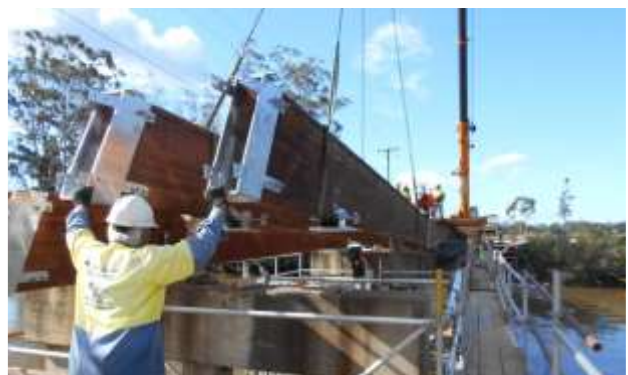
Figure 4-41: The new glulam superstructure and deck were installed on the existing substructure at Newry Island Bridge. Removal of the existing structure and installation of the new occurred in tandem to limit the road closure time.

Newry Island Bridge is a six-span timber bridge totaling 62m (203ft). The glulam girder and transverse deck replaced an older timber bridge, and used the existing substructure. The bridge is the only access to the neighborhood on Newry Island, so it was important to limit the time that the bridge was closed. Removal of the existing structure occurred in tandem with installation of the new bridge. Total closure time was limited to only eight days. During this time the municipality offered ferry service to provide access to residents. See Figure 4-41 below.

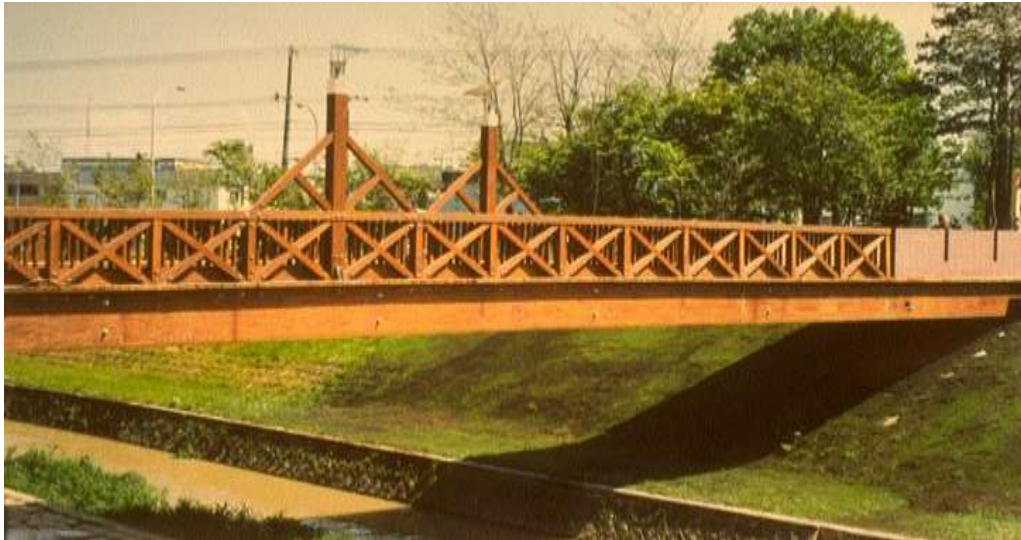
Figure 4-42: The new glulam superstructure was preassembled using 12 meter long sections of high strength fiber reinforced glulam beams. The bridge had a 1 meter depth girder limitation and high strength fiber reinforced glulam beams were the only economical option. This structure has been in place close to twenty-five years.
